RID: 8th Session of the RID Committee of Experts' standing working group
(Utrecht, 20 to 24 November 2017)

Subject: Extract of a report on a rail incident on 17 October 2017 investigated by the Dutch Human Environment and Transport Inspectorate of the Ministry of Infrastructure and Water Management

Information from the Netherlands

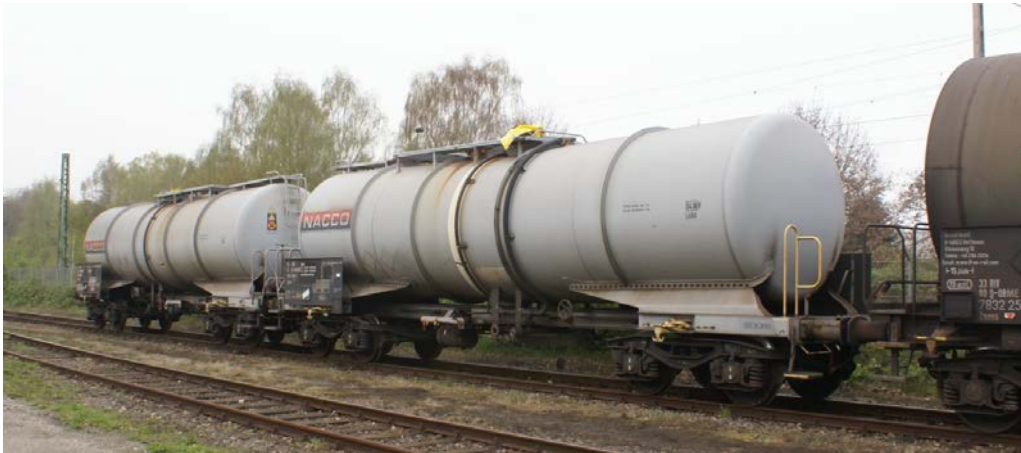
2. During the testing before loading both rail wagons were leaking from the top valves. There was slight leakage of the above-mentioned product. The consignee depressurized the tank-wagons and then refused to refill them. After emergency repairs, both tank-wagons had to be removed from the consignee's site. With the permission of the Dutch authorities the wagons were transported to facilities to be cleaned in accordance with RID 1.8.1.3, 4.3.2.4.3 and 5.4.1.1.6.3 (a). After the tank-wagons were cleaned, an investigation was carried out by the Dutch authorities on German territory with the permission of the Federal Ministry of Transport and Digital Infrastructure.

Both tank-wagons with spill bag emergency repair on top

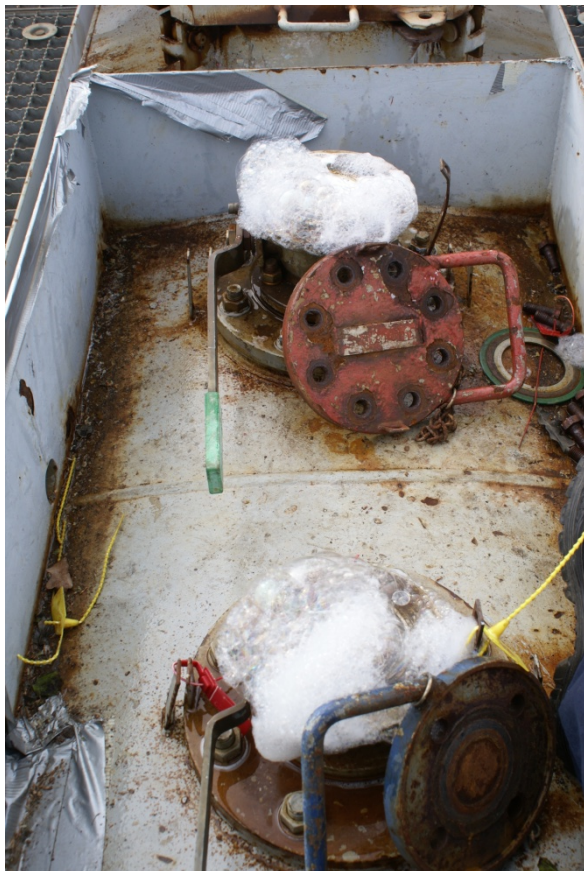
Wagon X was not gas tight. The wagon was leaking at:

- both top valves red and blue
- the side valve (at the break cylinder side)

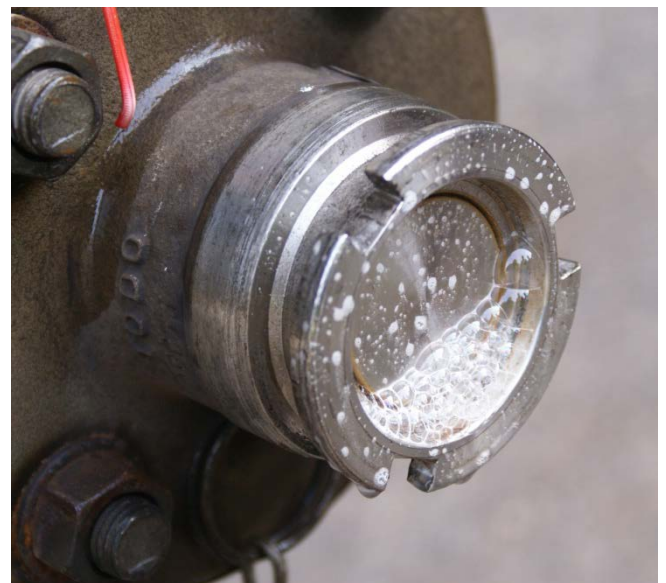
Wagon Y was not gas tight. This wagon was leaking at:

- both top valves red and blue

- the manhole seal topside
 - the TODO side valve (not the break cylinder side)
 - the bottom valve
 - the probe valve in front of the side valve (at the break cylinder side).
5. The top of both tank-wagons was not properly cleaned or maintained.
 6. The top valves were of the brand Bonetti Armaturen GmbH & Co KG, Type: ALFA 10 NF, CF8M, 50 and 80. All are types of ball valves.

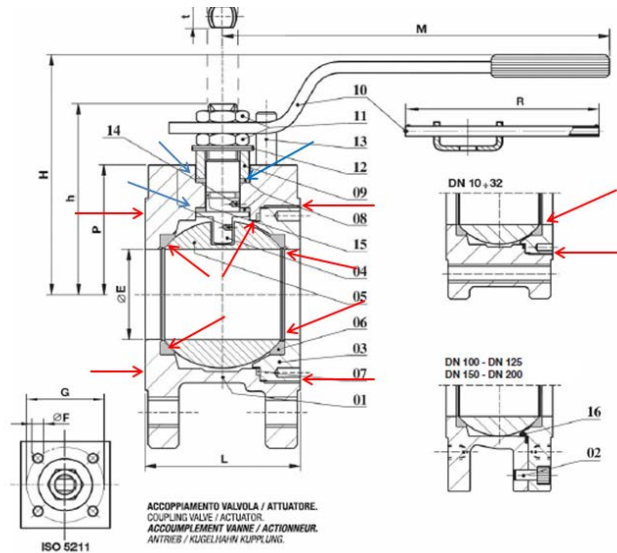
Drawing of the ball valve

Every red arrow in this drawing marks a point of leakage, as shown in the pictures.

No leakage was detected at the points shown by the blue arrows.

7. The closing ring of the ball valve was the main area of leakage.

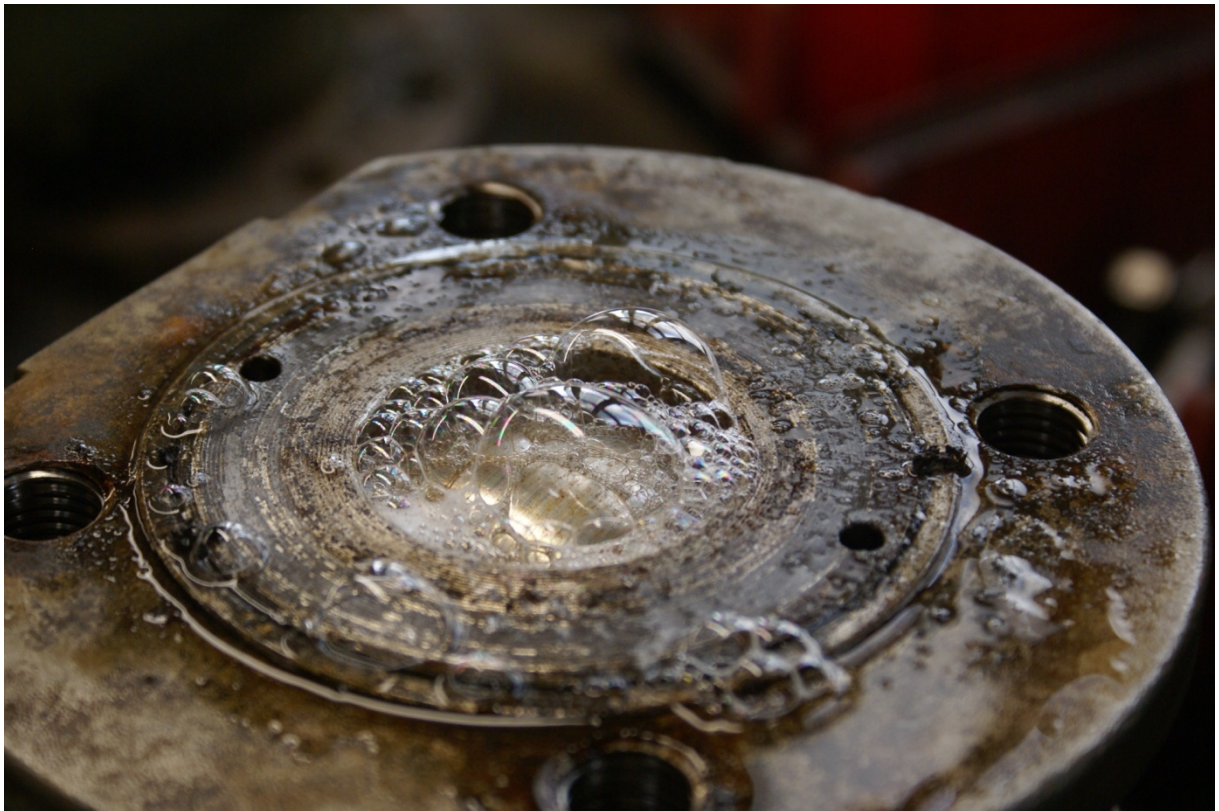
8. The ring was not closed correctly. It was only manually fastened, so it could easily be unlocked manually.

- The pressure ring was not mounted correctly. The ring was manually mounted and did not place sufficient pressure on the seals to be able to close the valve so as to be gas and vapour tight;

- In addition, the pressure/closing ring of the ball valve was not equipped with a technical system to secure the fastening. As a result of vibrations from the moving train, this ring could not be prevented from coming loose;

- After unloading, each loader of a tank-wagon should check that the valves are gas tight and are correctly assembled.
 - A technical system, e.g. a lock screw, to secure the fastening of the closing ring on the ball valve could prevent loosening of this ring in the future.
14. This information might be of use to all who wish to prevent future accidents caused either by human error or by technical problems such as those outlined above.
-

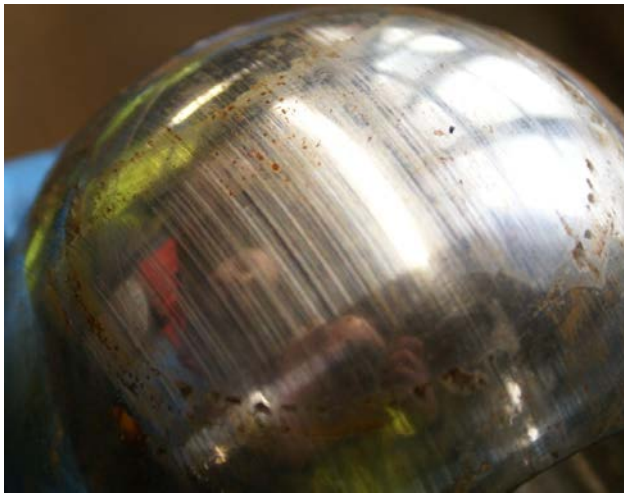
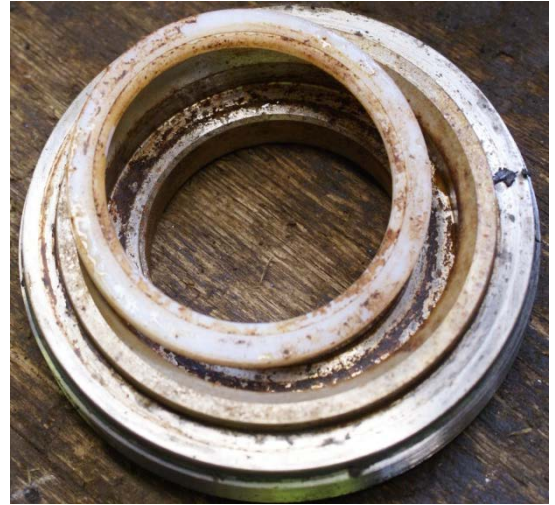
9. Below the closing ring there was a sealing ring that was damaged by rust particles. The ball of the valve was also damaged by the rust particles and was grooved at its surface.

10. All the Teflon seals were dented and dirty as a result of rust particles. None of the seals and balls were fully functioning and gas tight.
11. The damaged parts were removed and repaired or replaced by new parts. After a new pressure test all parts were closed and again certified.

12. The cause of the leaking valve was both a technical defect and human error and can be explained as follows:
 - There were a lot of rust particles in the valve and both the Teflon seals and the ball of the valve were damaged (see pictures);

13. The Dutch Inspectorate is of the opinion that these problems could possibly be prevented if the following prevention measures are taken:
 - Before closing with the blank flange, each loader and/or unloader should be certain that the equipment is clean and in good technical order for each subsequent journey. The vertical mounting of these valves makes them more vulnerable to the ingress of dirt or dirt staying in the head of the valve. Turning the valve with a dirty interior will scratch the ball of the valve and damage the seals. It was particularly the flakes of iron rust that caused the damage to the hard Teflon seals.
