**OTIF/RID/CE/GTP/2017/11**

**RID:** 8<sup>th</sup> Session of the RID Committee of Experts' standing working group  
(Utrecht, 20 to 24 November 2017)

**Subject:** Incident in Offenburg on 12 October 2016

### Information from Germany

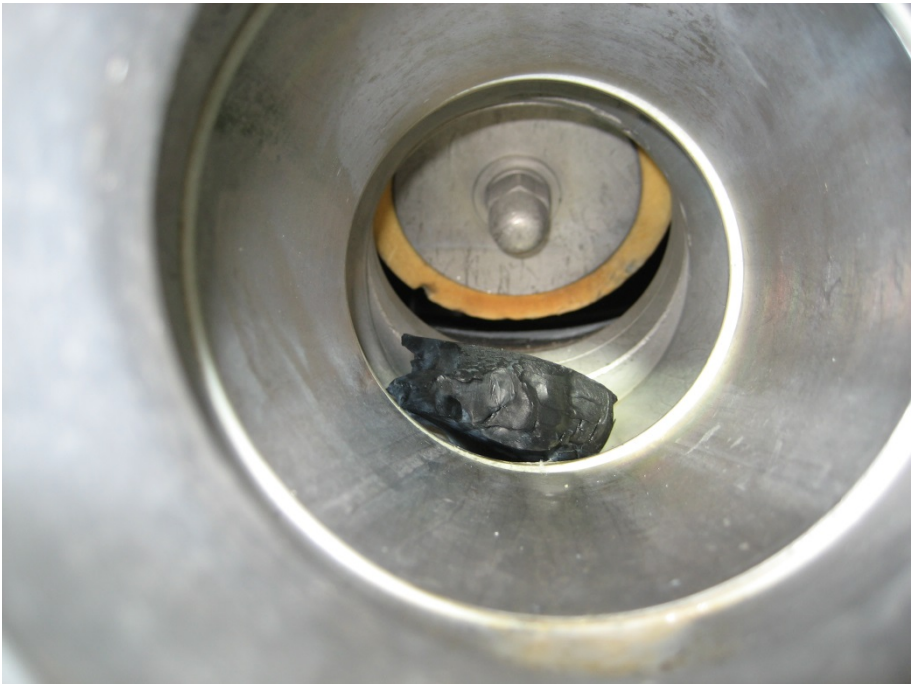
8. The Federal Railway Office ordered an exceptional check of the tank-container in accordance with RID 6.8.2.4.4. In the course of a visual inspection of the bottom valve, it was noted that there was a large foreign body in the bottom outlet of the tank-container. The foreign body turned out to be a piece of rubber about 6 cm long and 3 cm wide, but it was not from the tank-container itself (see picture 1).

Picture 1: Foreign body in bottom outlet

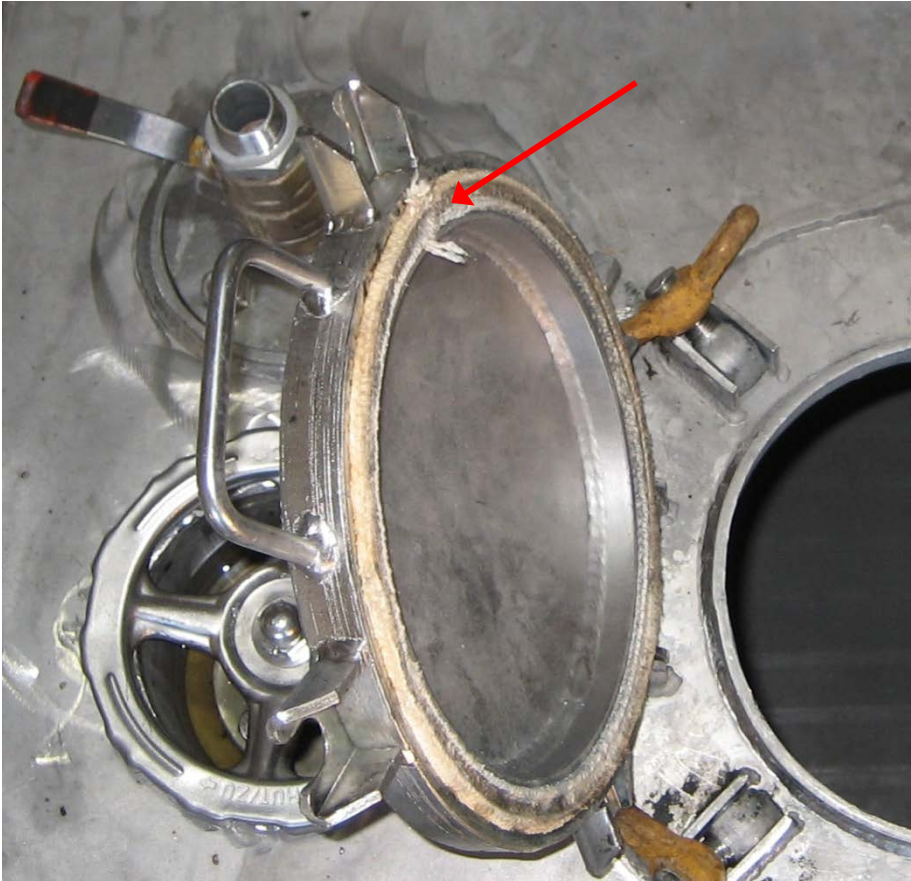
9. When the dome cover seals were checked, it was noted that the sealing on all four dome covers was damaged (see picture 2). In addition, when the middle dome case was checked, it emerged that the identification plates had become separated from the bursting discs on the safety valves. The separated identification plates had been welded onto the connecting flange of the safety valves (see picture 3).

Picture 2: Damage to the seal on a dome cover

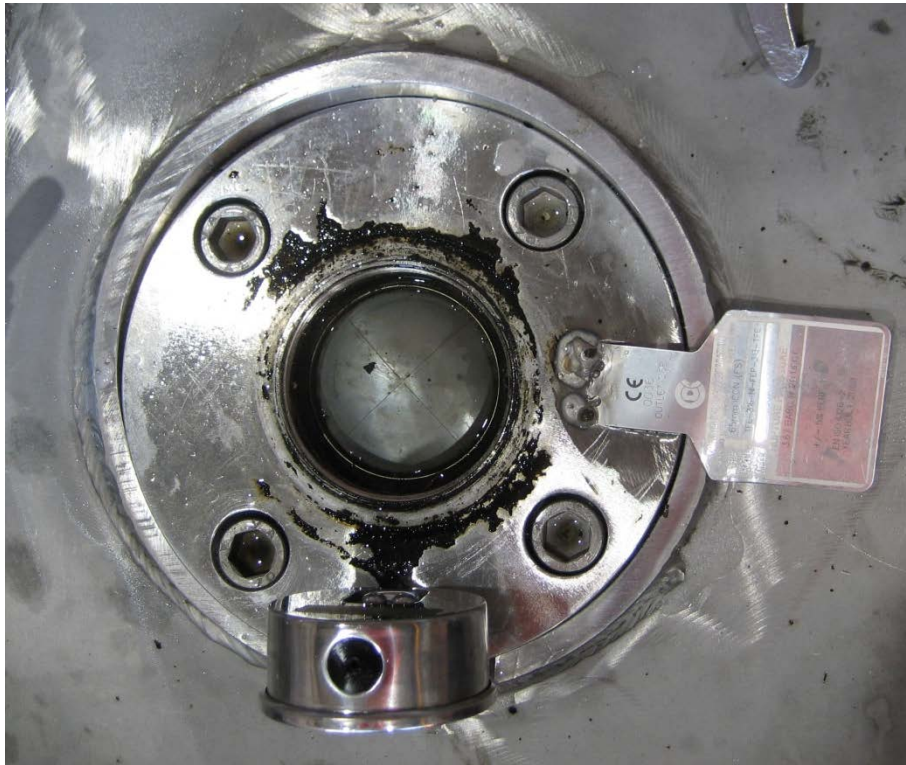
11. Following the pressure test, both safety valves on the tank-container were dismantled. Impurities were found between the bursting disks and the safety valves, which indicate that the area around the flanges is leaking (see picture 3). Apart from the separated identification plates, which meant that the bursting disks could not be identified, the bursting disks that were installed were intact. The functioning of both safety valves was checked using a test rig. The safety valve on the left side in the direction of travel, whose identification plate indicated a start-to-discharge pressure of 3.71 bar, opened at only 2.0 bar. The safety valve on the right side in the direction of travel, whose identification plate indicated a start-to-discharge pressure of 3.31 bar, also opened at only 2.0 bar. Thus neither of the two safety valves showed the correct functioning.

Picture 3: Separated identification plate of a bursting disk, welded onto the connecting flange of the safety valve

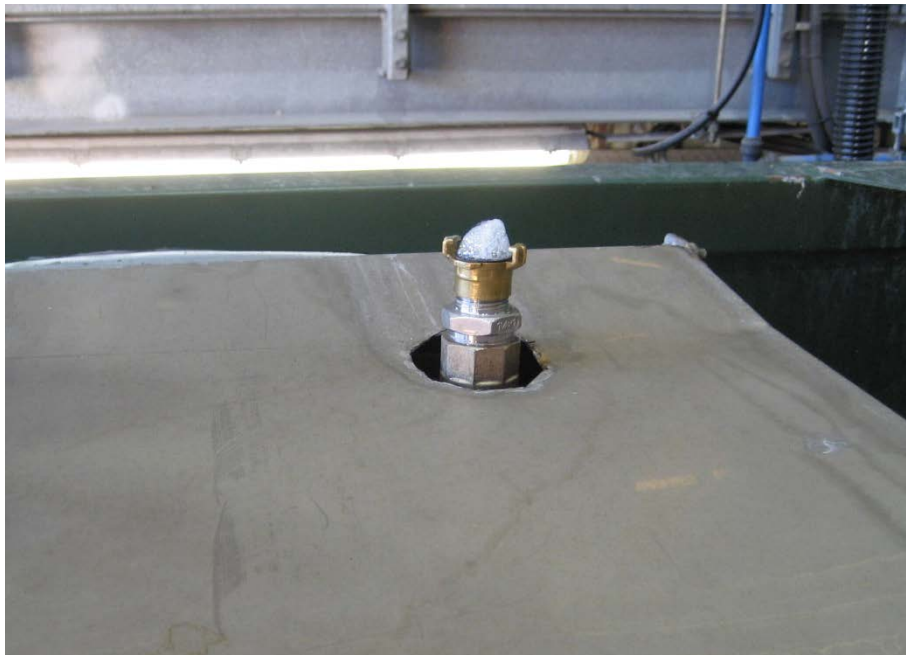
12. The tank-container's gas displacement nozzle was around 5.5 cm above the clearance height of the tank-container and the dome case. To be able to close the dome case cover, a hole had evidently been cut in the cover (see picture 4). As there was a risk that the protruding connection might cause damage to other tank-containers if they were stacked (e.g. in transshipment terminals), it was dismantled.

Picture 4: Gas displacement nozzle with part cut out of dome case cover
