**OTIF/RID/CE/GTP/2017/13**

**Subject:** Shunting accident in Antwerp on 4 January 2017

### Information from Belgium

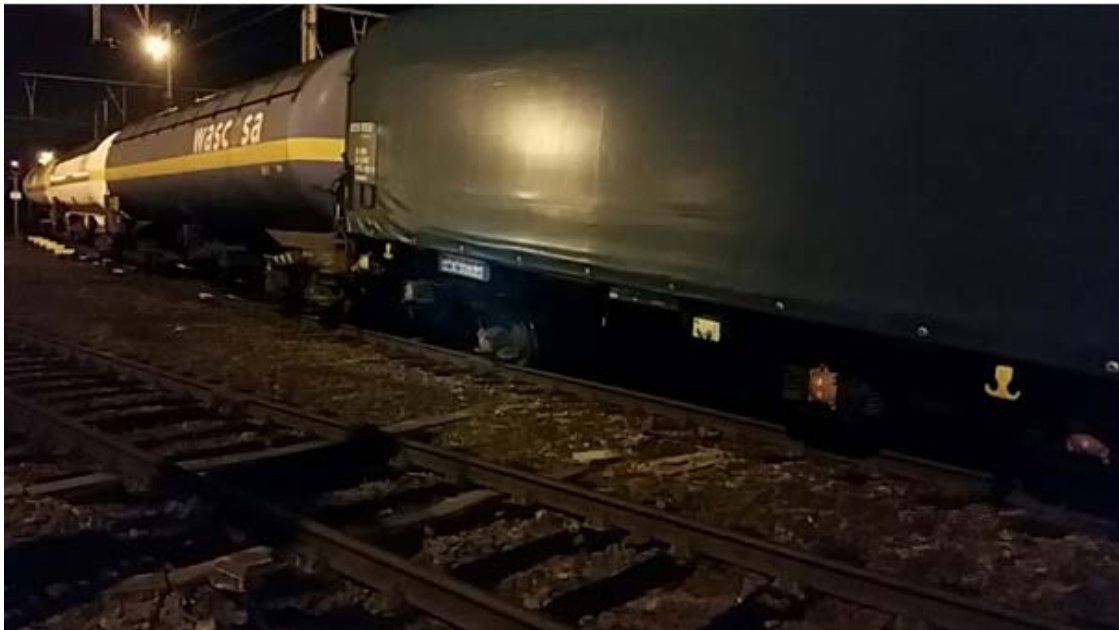
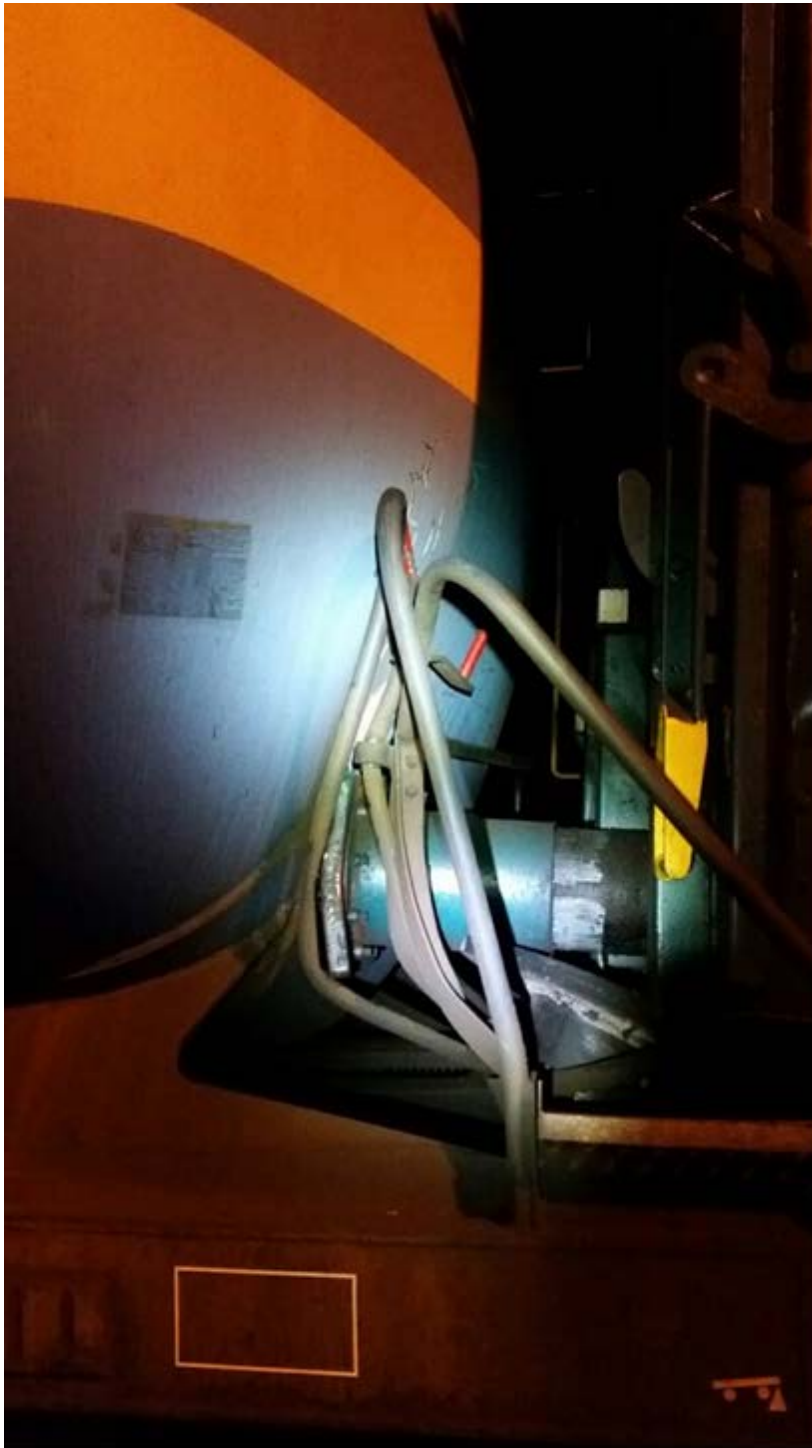
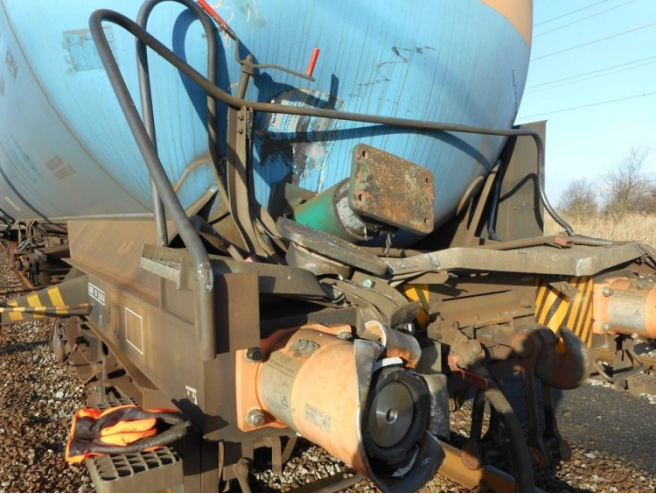
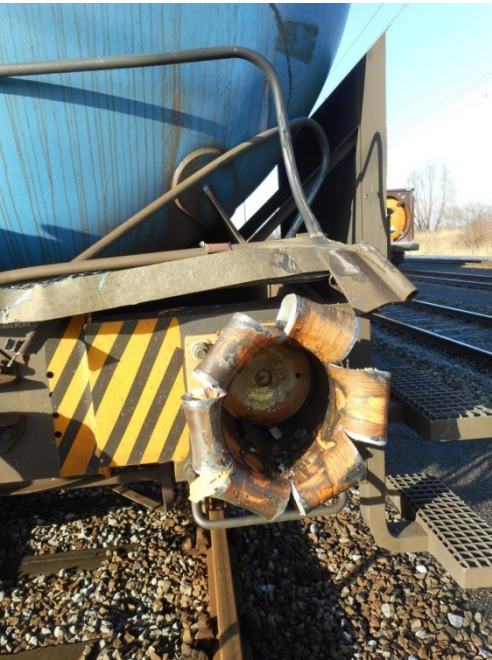
### Description and photos of the damaged tank-wagon

1. On 4 January 2017 a collision caused by a marshalling error occurred at Antwerp marshalling yard, followed by a derailment.
2. Four 50 tonne tank-wagons carrying isobutylene (23 UN 1055) were involved.
3. One of these wagons was severely damaged. The crash buffers worked and the tank was deformed. There were no leaks.
4. Although there were no leaks, this accident met the “material damage” criteria of “> 50,000 euros” of RID 1.8.5. The competent authority was sent a report in accordance with 1.8.5.3. As this was prepared in Dutch, we have reproduced heading 5 (description of the accident) in paragraph 6 of this document and heading 7 (cause of the accident) in paragraph 7 of the document.
5. The investigating body did not open a file following this accident.

7. The brake distributor on the first wagon of the first group had not been sufficiently purged and it stopped prematurely. The investigation is ongoing.

Tank code: P25BH

Thickness of tank end: 14 mm

Fitted with crash buffers (TE 22)
