OTIF/RID/CE/GT/2009/1

RID: 10th Meeting of the Working Group on Tank and Vehicle Technology
(Brussels, 11 and 12 June 2009)

Subject: Notification of occurrence in accordance with RID 1.8.5

Accident report in accordance with 1.8.5 – derailment of 3 RID tank-wagons (empty, uncleaned) – minor leakage of product – 23/1032.

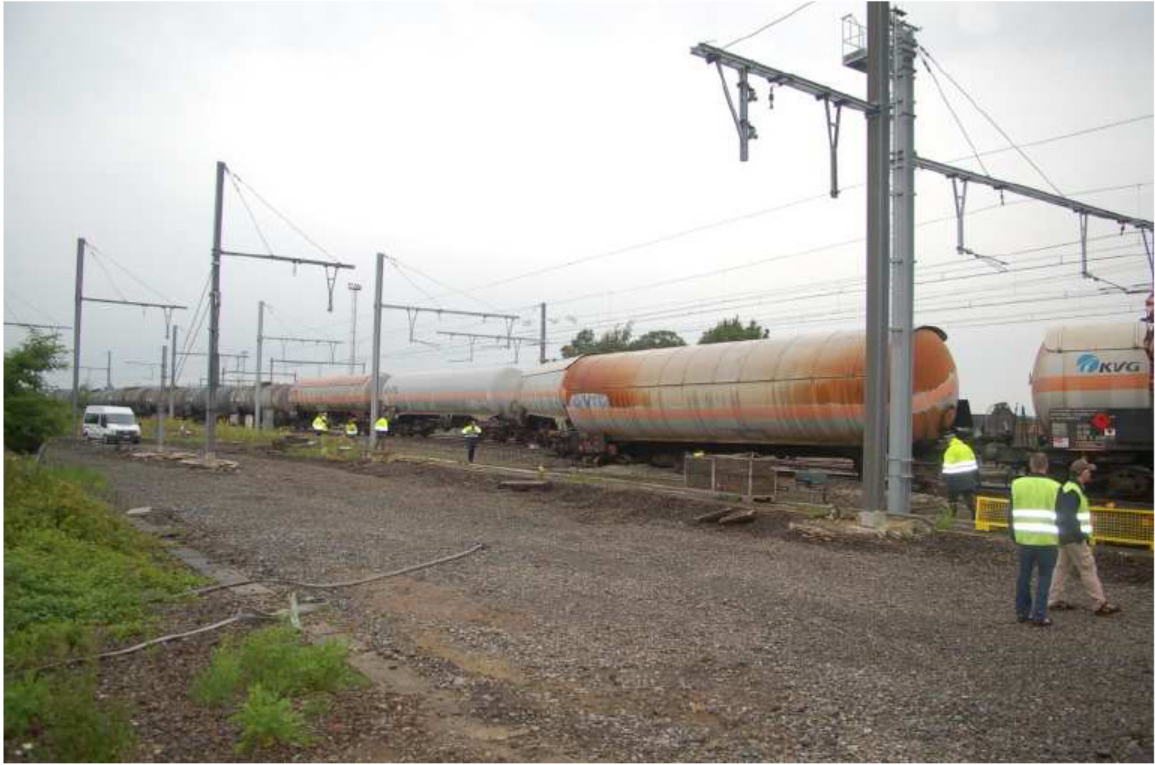
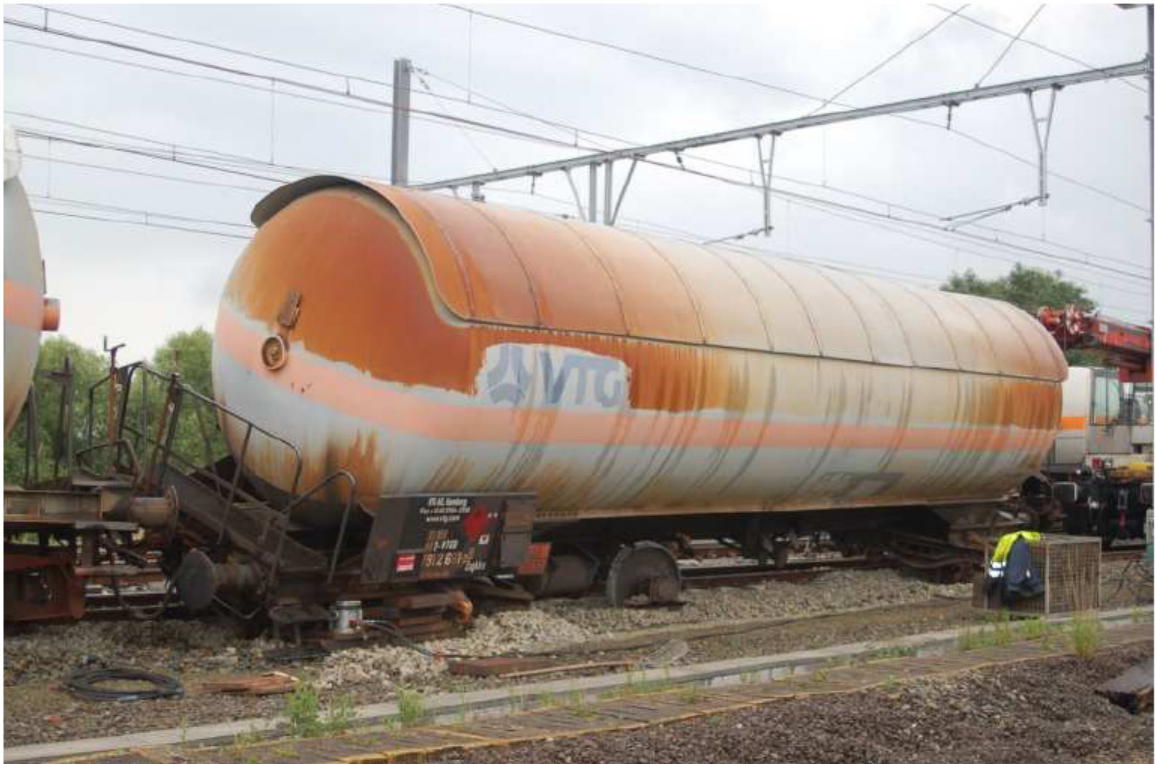
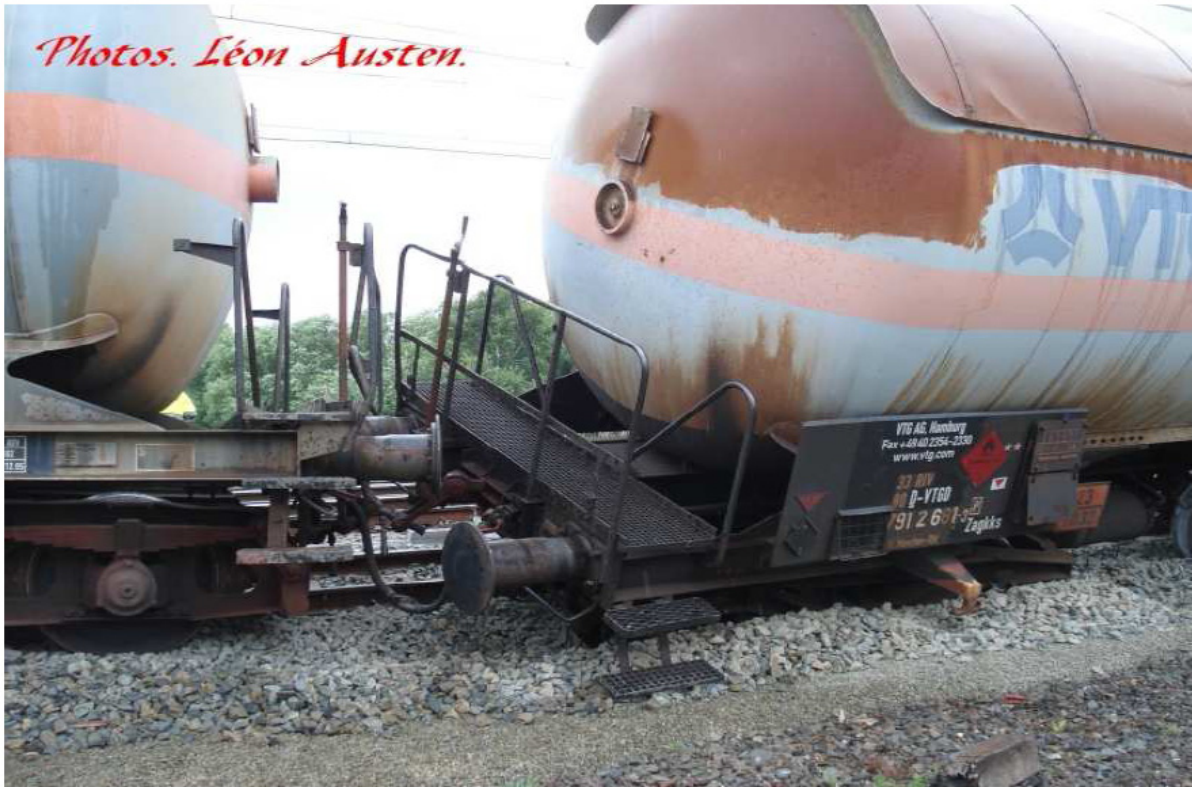
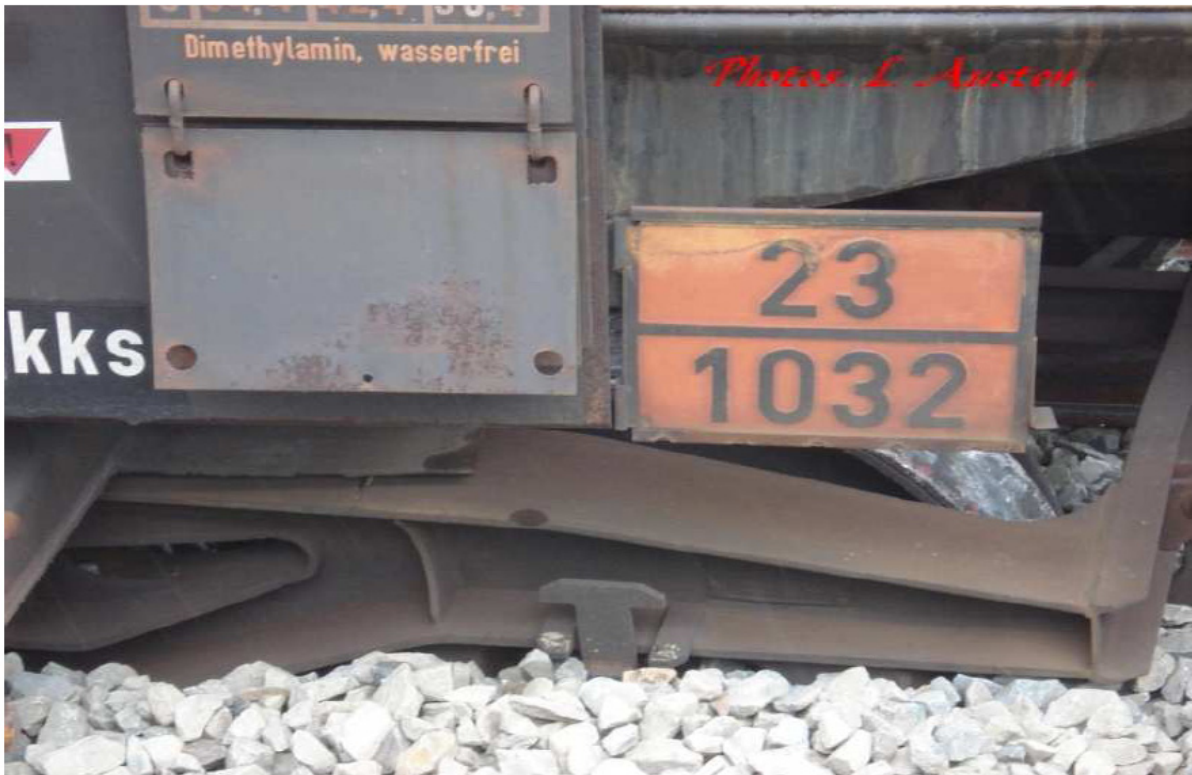
Montzen – 09.07.2008

Relatively major damage to track, sleepers and points.

20th wagon: both bogies of this wagon derailed and it tipped over $\pm 45^\circ$. There was major damage to the bogies and damage to the discharge device. The pipes for the liquid and gas phases were crushed between the bottom valves and the discharge valves. As a result, there was slight leakage (10 drops per minute) at the back of the discharge valve. The emergency services emptied the rest of the product present in the pipe and tightened all the bolts. No leakage was observed after this had been done.

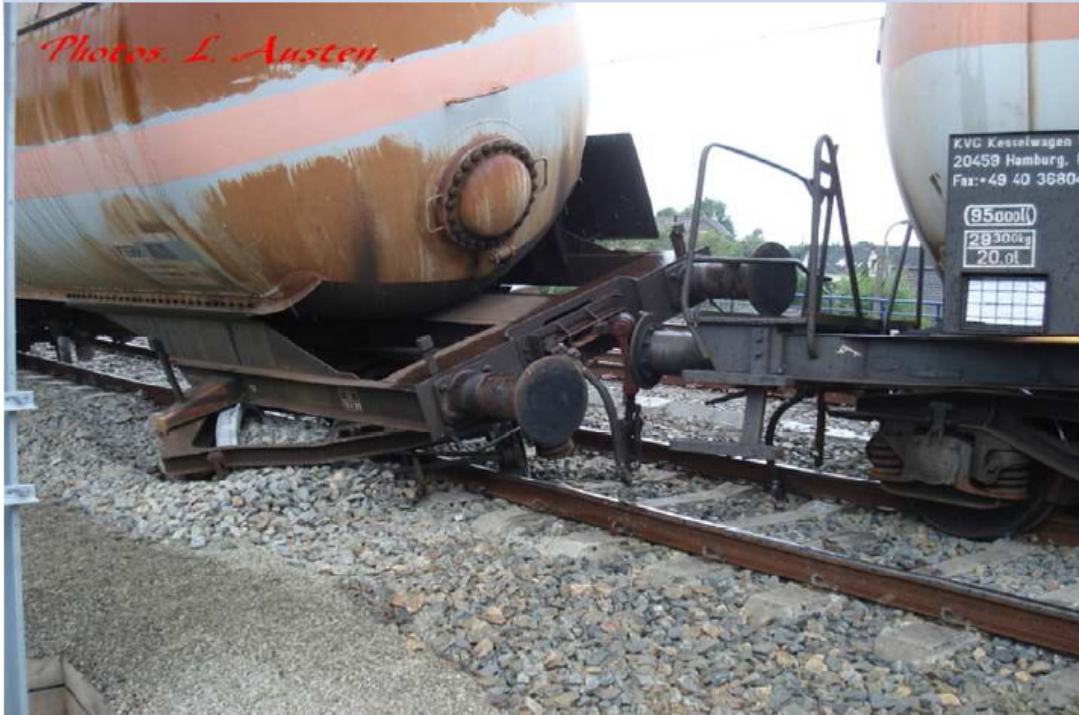
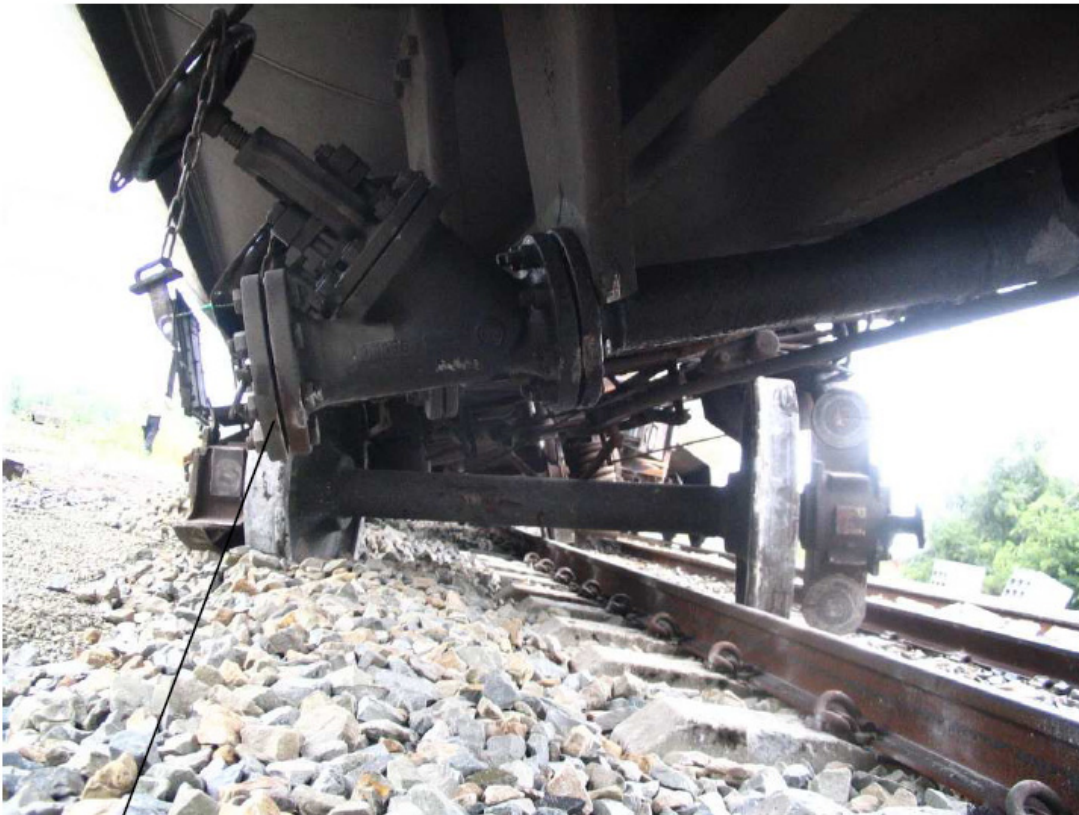
Loss of product
