OTIF/RID/CE/GT/2010/2

RID: 11th Meeting of the Working Group on Tank and Vehicle Technology
(Berne, 18 and 19 May 2010)

Subject: Report rail accident at Barendrecht

Transmitted by the Netherlands

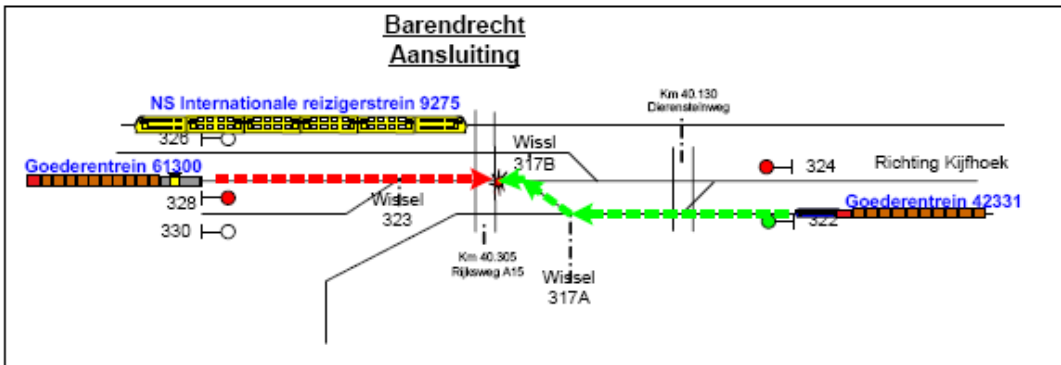
Figure 3: Situation sketch of the collision

At around 22:30 on Thursday 24 September 2009, two freight trains collided head-on at Barendrecht junction (Barendrecht Aansluiting). A Benelux passenger train approaching on an adjacent track collided with a derailed freight wagon.

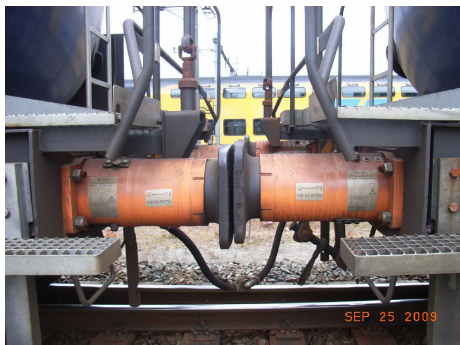
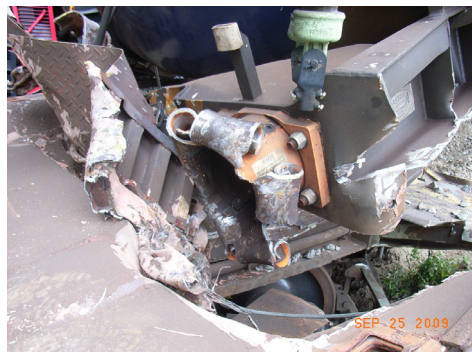
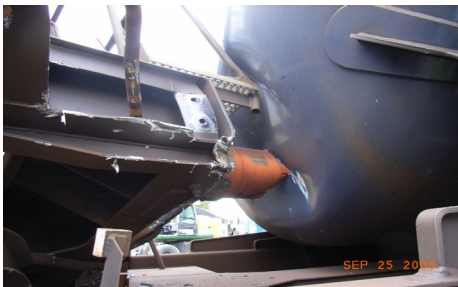
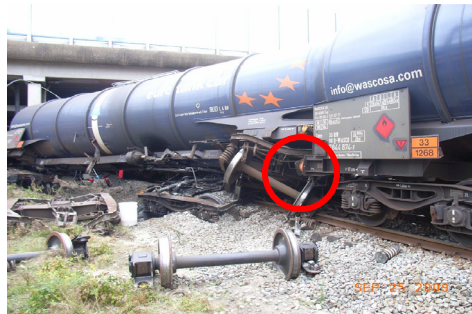
The first two tank-wagons of train 61300 were so badly damaged that they had to be emptied (by pumping) before they could be moved. Initially, the accident response crew of railway infrastructure manager ProRail planned to raise the loaded tank – which had been ripped off the wagon's under-

The 7 tank-wagons containing UN 1268 (HIN 33), natural gas condensate were all fitted with crash buffers, although these are not legally required for the substance in question (3.2, column 13) under section 6.8.4 of the RID.
