**OTIF/RID/CE/GT/2010/2/Rev.1**

**RID:** 11<sup>th</sup> Meeting of the Working Group on Tank and Vehicle Technology  
(Berne, 18 and 19 May 2010)

**Subject:** Report rail accident at Barendrecht

**Transmitted by the Netherlands**

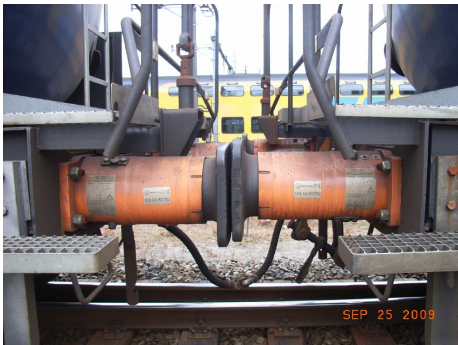
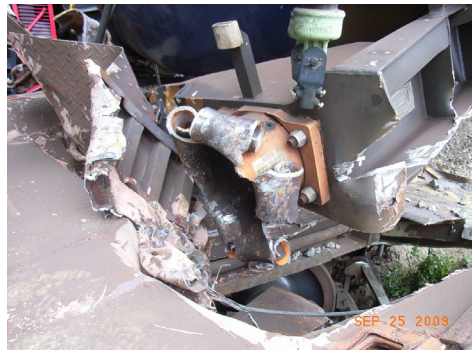
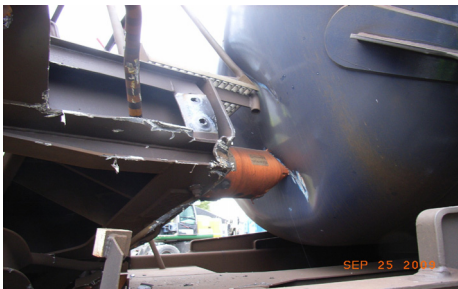
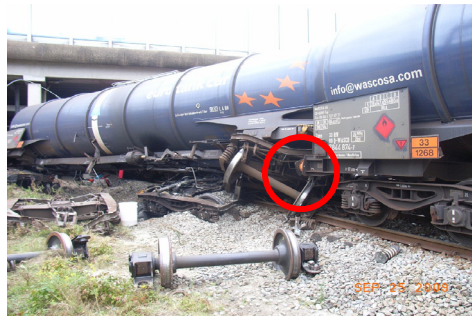
The first two tank-wagons of train 61300 were so badly damaged that they had to be emptied (by pumping) before they could be moved. Initially, the accident response crew of railway infrastructure manager ProRail planned to raise the loaded tank – which had been ripped off the wagon's under-

The 7 tank-wagons containing UN 1268 (HIN 33), natural gas condensate were all fitted with crash buffers, although these are not legally required for the substance in question (3.2, column 13) under section 6.8.4 of the RID.
