The following report is based on the *Model for report on occurrences during the carriage of dangerous goods* in accordance with RID 1.8.5.4. Detailed information on this accident and what caused it can be found in the report by the Dutch Safety Board (OvV). The report is available via the following link:  
<https://www.onderzoeksraad.nl/uploads/phase-docs/1194/bf794f7757b1treinbotsing-tilburg-en-interactief.pdf>

**INF. 5**

**RID:** 7<sup>th</sup> Session of the RID Committee of Experts' standing working group  
(Prague, 22 to 24 November 2016)

**Subject:** Report on a rail accident at Tilburg on 6 March 2015

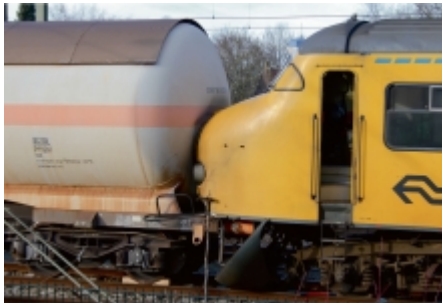
### The collision

siding that was too short. As a consequence, the rear wagon was so close to a switch that the signal for the passenger train remained red. The driver of the passenger train did not notice the red signal. The passenger train ran into the freight train. The front part of the passenger train climbed during the collision, and ended up against the tank of the butadiene tank-wagon.

6. Because the passenger train was of an older type which does not have buffers, the front part of the passenger train climbed during the collision, and ended up against the tank of the butadiene tank-wagon.

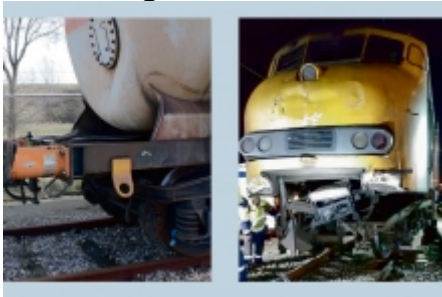
### The damage

2. On 6 March 2015 a passenger train collided with a stationary freight train carrying dangerous substances at Tilburg in the Netherlands. Eight people on the passenger train were slightly injured. The last tank-wagon of the freight train was damaged and leaked butadiene (UN 1010). Some police officers became unwell after inhaling the escaped gases.
3. In response to the accident the [Dutch Safety Board](#) (Onderzoeksraad voor Veiligheid) carried out an investigation and published the report "Risicobeheersing bij spoorvervoer" (Risk management in railway transport) in which it has made several safety recommendations to the Ministry of Infrastructure and the Environment, the railway infrastructure manager, carriers and chemical companies.

7. The "climbing" of the passenger train was able to occur because the tank-wagon was not equipped with protection measures against overriding of buffers. Such protection is only mandatory for tank-wagons containing very toxic substances.

9. The Dutch Safety Board highlighted in its report the importance of supply chain responsibility. It recommends rail companies not to make operational decisions that lead to an increase in known and managed safety risks. In addition, the Board recommends that passenger train railway undertakings should not use train types with poor collision compatibility on routes designated for the transport of dangerous goods.
10. Furthermore, the Board is of the opinion that the Minister of Infrastructure and the Environment should require that all types of tank-wagons be protected against overriding of buffers, and that the rear wagon of a freight train may not contain any dangerous goods.

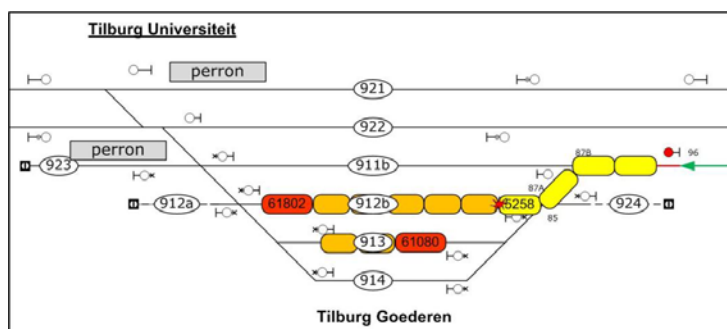
### Situational overview

4. The freight train was coming from the Chemelot chemical park in South Limburg and was en route to Rotterdam. Due to an adjustment in the schedule, the train left three hours later than originally planned and the carrier decided to stop in Tilburg to allow for a change of driver. When requesting the stop, the carrier's report on the length of the train was inaccurate, with the result that the train service management directed the train to a
