OTIF/RID/CE/GTP/2012/8

Subject: Report on a rail accident at Kijfhoek marshalling yard (near Zwijndrecht) on
14 January 2011

Transmitted by the Netherlands

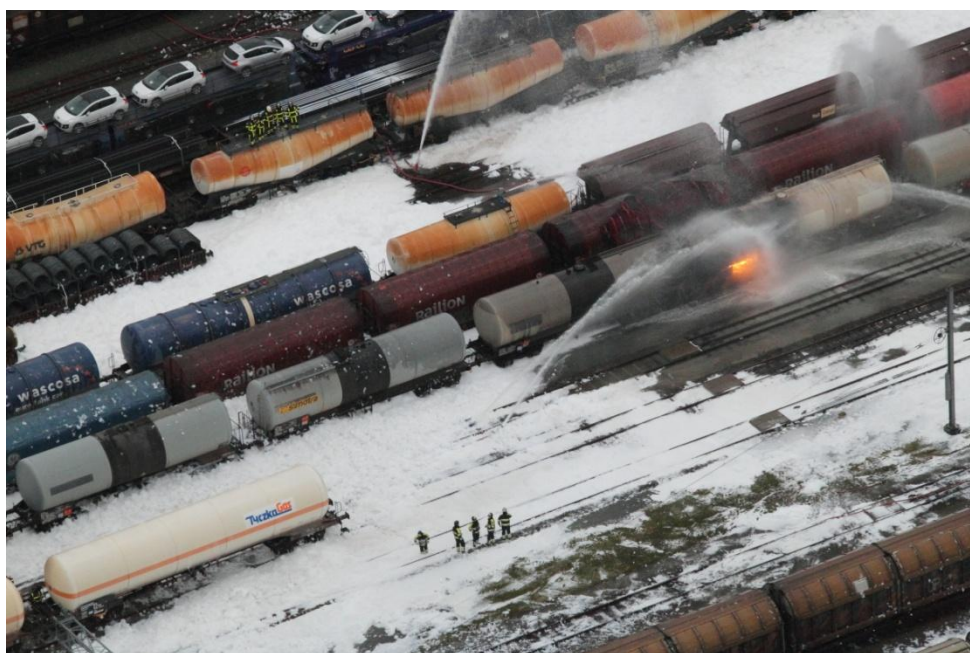
Photo 1

Kijfhoek track no.	Wagons and dangerous goods involved (see also photo 1)
132	covered wagons loaded with steel (1 wagon caught fire)
131	20 tank wagons loaded with UN 1170 ethanol (1 wagon caught fire), 2 tank wagons with UN 1131, 1 tank wagon empty uncleaned of UN 2447 and 1 wagon loaded with a tank-container empty uncleaned of UN 3394
130	Empty track
129	23 tank wagons, empty and cleaned of LPG

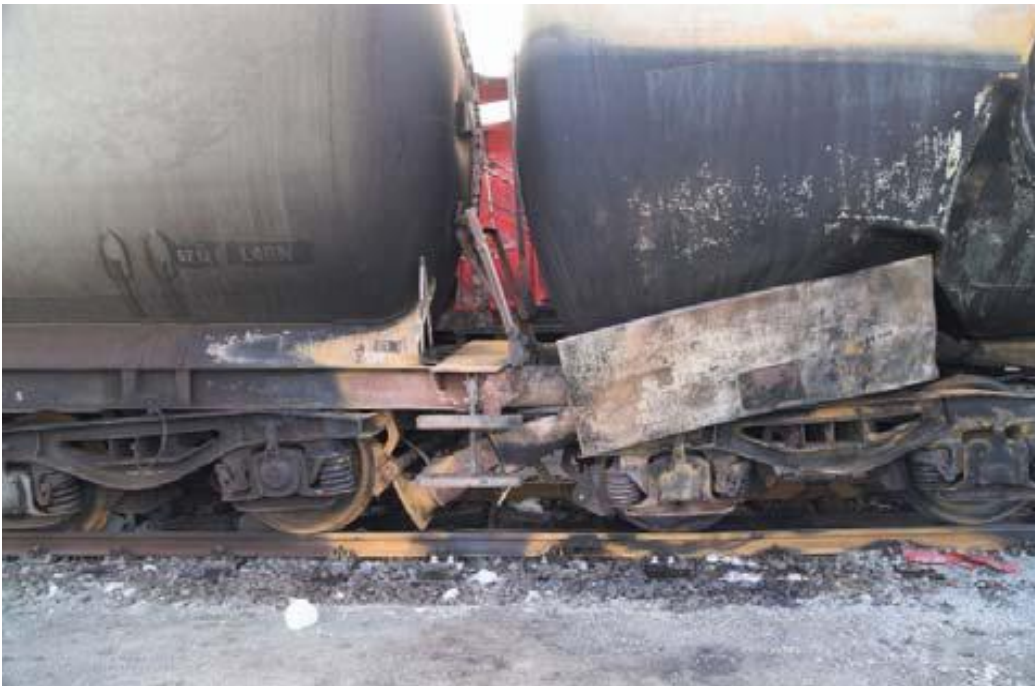
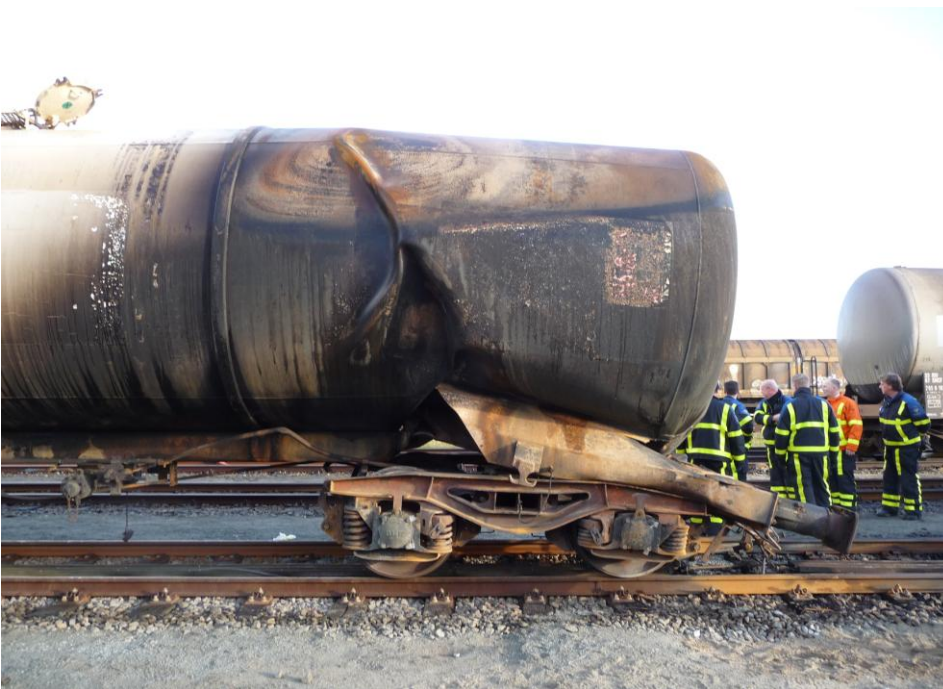
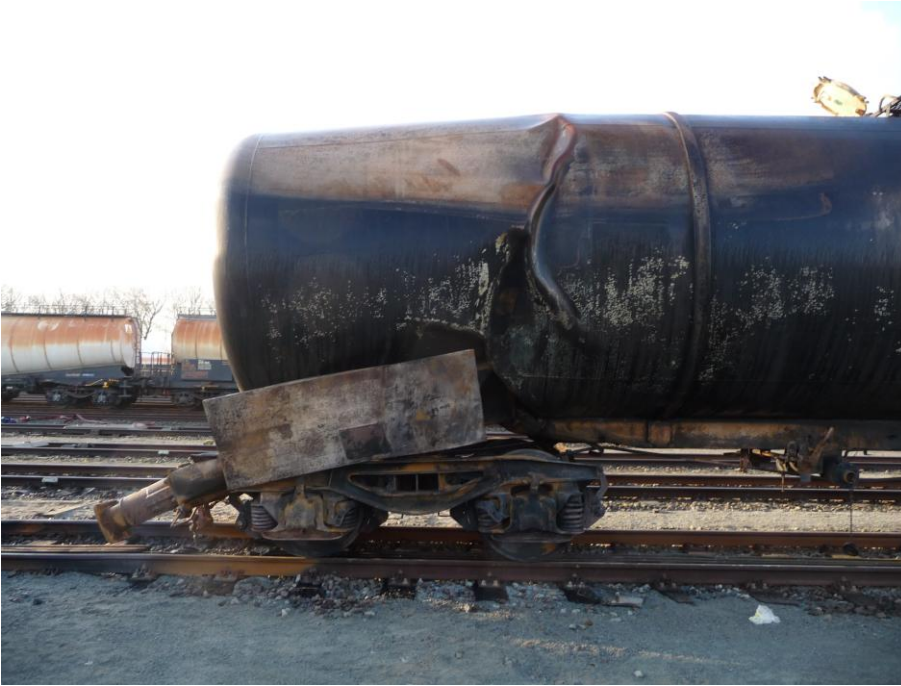
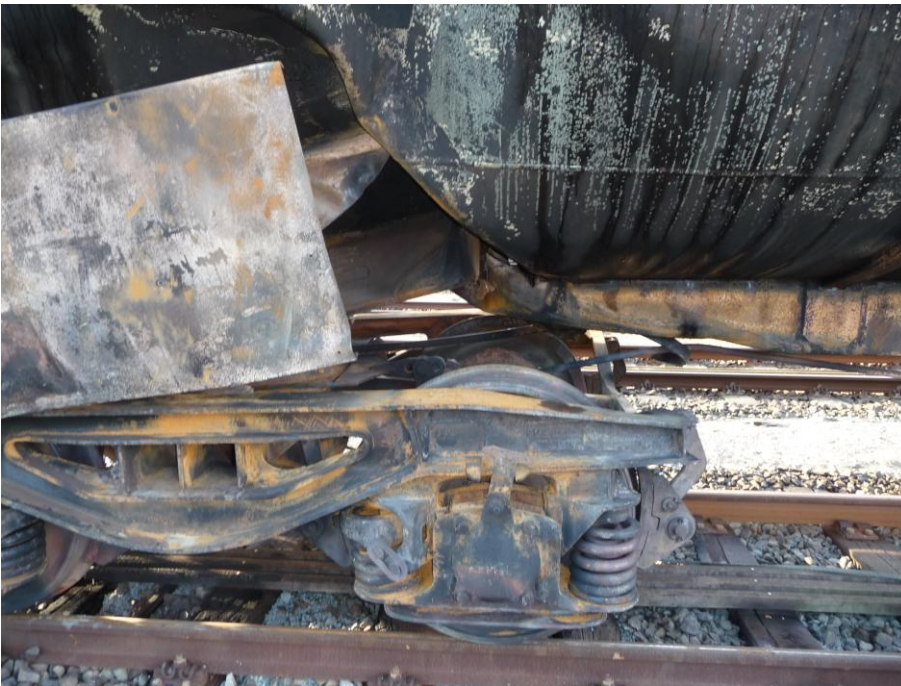
After the first collision one set of wagons rolled back. The damage picture and calculation demonstrated that the second collision was the most severe and occurred at an impact speed of around 24 km/h. During these collisions the frames of some wagons buckled. The buckle in the frame of one wagon was such that the tank leaked ethanol, which then caught fire. The frame of this wagon had one beam in the middle of the car. This beam serves to connect the two wagon ends (for longitudinal forces from the buffers) and to support the tank. Other tank-wagons in the train had two beams, one left and one right, in line with the buffers.

In the burnt out wagon and some other wagons involved in the collision the buckle occurred on the same spot of the frame; the buckle was most severe in the burnt out ethanol wagon, which endured the highest impact (see photos 3-6).

Photos of burnt out tank wagon with buckled supporting beam

Nowadays more crash resistant buffers (so called crash buffers) are on the market, which can absorb more energy². These crash buffers are only obligatory for goods that are more dangerous than ethanol. Crash buffers could reduce the consequences of the accident, but the investigation has not demonstrated that with certainty.
