OTIF/RID/CE/GTP/2014/18

Subject: Report on incidents in the carriage of dangerous goods in accordance with RID
1.8.5 (Hamburg-Billwerder, 3 July 2013)

Information from Germany

**Extract from the Eisenbahn-Bundesamt (EBA) report
(Hamburg/Schwerin branch) dated 4 July 2013**

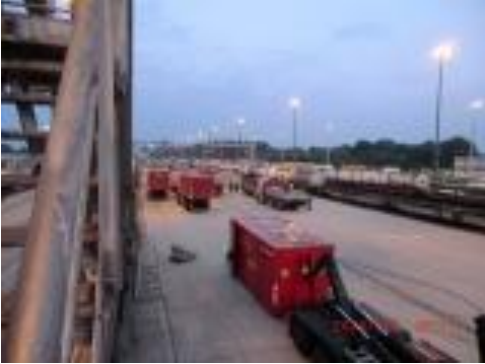
On 4 July 2013, the Hamburg-Billwerder transshipment station informed EBA of a leaking tank-container (incident: 3 July 2013 at about 7.40 pm). Around 2,400 litres of hexanol had leaked and the Hamburg fire brigade had responded with a large number of emergency response teams.

Photograph 1: Incident site during the emergency response

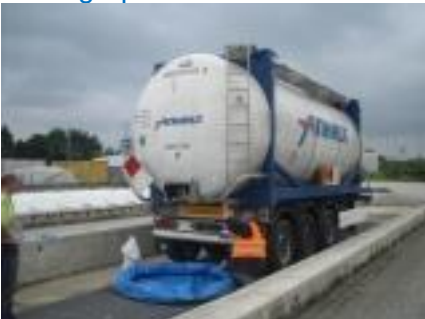
1. On 3 July 2013, tank-container ANHU 235 159 – 0, loaded with 25,800 kg 30 UN 2282 HEXANOL, 3, III, was to be transhipped from a road vehicle onto a carrying wagon.
2. The crane operator failed to set the tank-container directly onto the attachment pins, and when turning, touched the supporting frame on the carrying wagon. The fittings cabinet was bent upwards and the load leaked.
3. The fire brigade was unable to take effective measures to seal off the leak on the carrying wagon.
4. A replacement tank-container was requested and the load was pumped into this replacement.
5. A trailer was used to bring the damaged tank-container onto a drip collection device.

Photograph 2: Tank-container in the drip collector next day

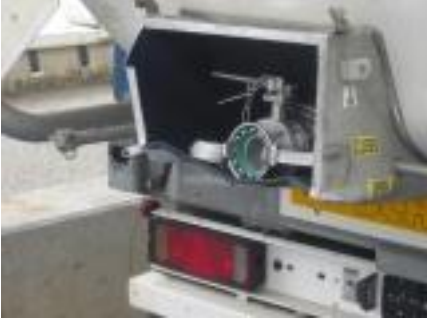
Photograph 3: Close-up of the fittings cabinet bent upwards

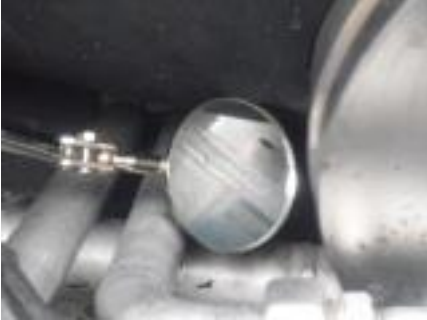
Photograph 4: Damaged weld seam

As no further measures could be taken in situ, the empty, uncleaned tank-container was taken to the workshop (by lorry) to be repaired.

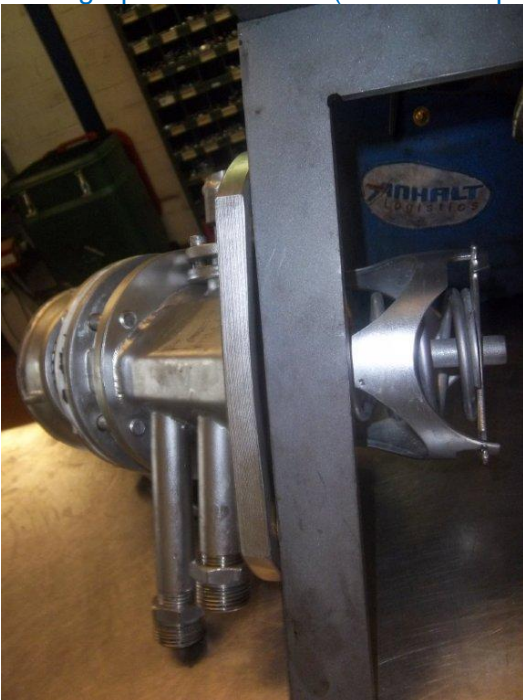
The damaged parts were removed in the workshop. The buckling on the valve attachment plate was clearly visible.

Photograph 5: Valve unit (attachment plate is buckled)

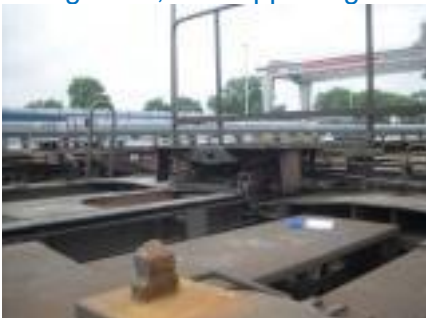
Photograph 9: At the front, an attachment pin for receiving the load unit can be seen and in the background, the supporting frame for receiving the kingpin of the trailer.

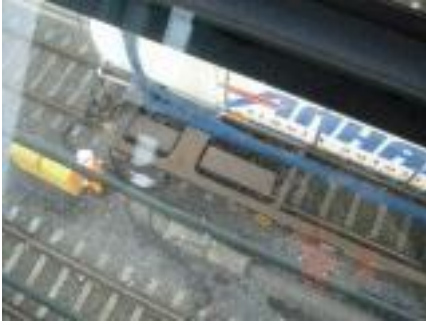
Photograph 10: Crane operator's view of the loading operation

If you consider the view the crane operator has and the movement of the tank-container on the crane's suspension cables (caused by movement of the crane or wind or surging movements), repetition cannot be ruled out.

Those involved informed EBA that there was already a set of operating instructions for this: All tank-containers (i.e. not just the so-called swap tank-containers) should, without exception, be loaded onto pocket wagons (design type 743) in such a way that the fittings are toward the middle of the wagon. All crane operators were notified of this rule in an official training session and they confirmed this with their signature. In addition, the other terminals belonging to this operator were informed of the incident and the rule that had been decided.

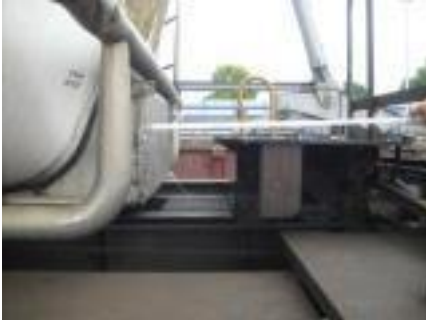
After the tank-container has been placed onto the carrying wagon, it can be seen that there is only a 20 cm gap between the tank and the supporting frame.

Photograph 11: Close-up view – Distance between tank-container/support frame – here: 20 cm
