**INF.2**

**Subject:** Report on incidents in the carriage of dangerous goods in accordance with RID  
1.8.5 (Hamburg-Billwerder, 3 July 2013)

### Information from Germany

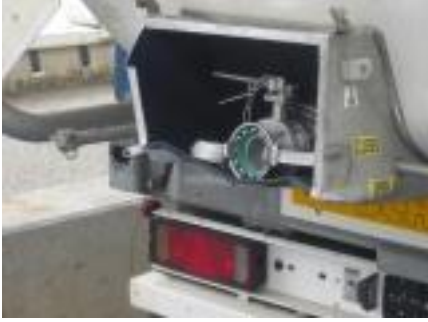
Photograph 3: Close-up of the fittings cabinet bent upwards

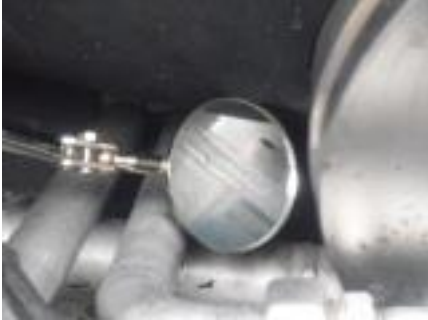
Photograph 4: Damaged weld seam

As no further measures could be taken in situ, the empty, uncleaned tank-container was taken to the workshop (by lorry) to be repaired.

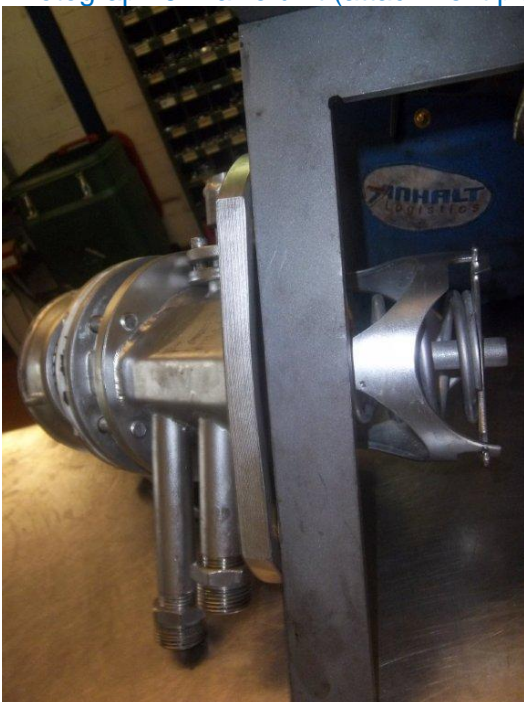
The damaged parts were removed in the workshop. The buckling on the valve attachment plate was clearly visible.

Photograph 5: Valve unit (attachment plate is buckled)

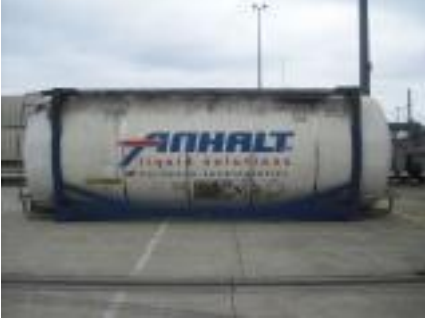
Photograph 6: Tank-container of same construction

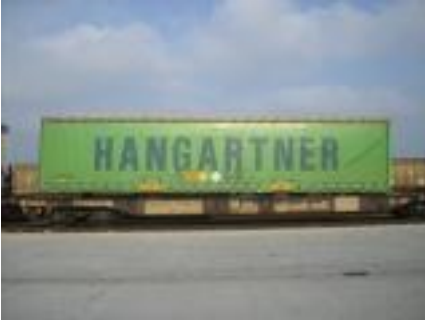
Photograph 7: Illustrative photograph – Loading a trailer onto a pocket wagon

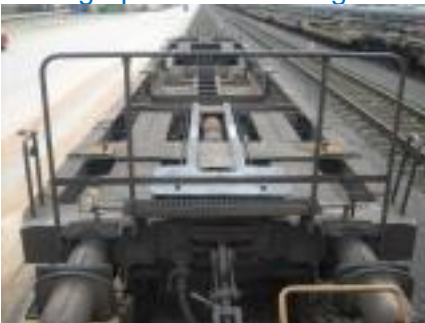
Photograph 8: Pocket wagon of same construction

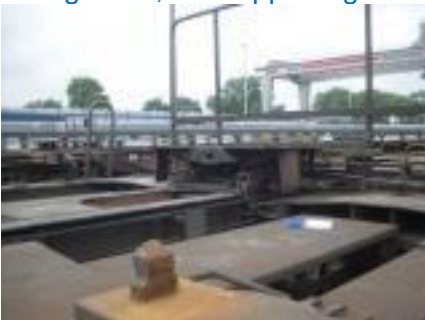
Photograph 9: At the front, an attachment pin for receiving the load unit can be seen and in the background, the supporting frame for receiving the kingpin of the trailer.

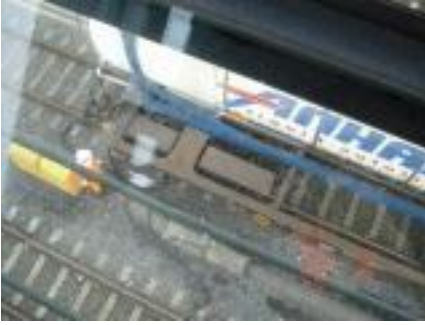
Photograph 10: Crane operator's view of the loading operation

If you consider the view the crane operator has and the movement of the tank-container on the crane's suspension cables (caused by movement of the crane or wind or surging movements), repetition cannot be ruled out.

Those involved informed EBA that there was already a set of operating instructions for this: All tank-containers (i.e. not just the so-called swap tank-containers) should, without exception, be loaded onto pocket wagons (design type 743) in such a way that the fittings are toward the middle of the wagon. All crane operators were notified of this rule in an official training session and they confirmed this with their signature. In addition, the other terminals belonging to this operator were informed of the incident and the rule that had been decided.

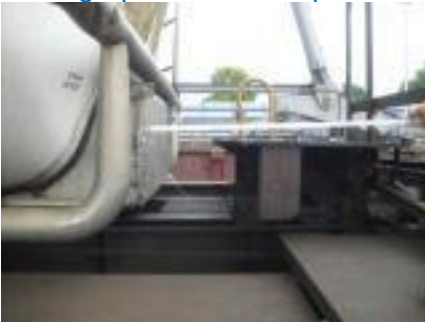
After the tank-container has been placed onto the carrying wagon, it can be seen that there is only a 20 cm gap between the tank and the supporting frame.

Photograph 11: Close-up view – Distance between tank-container/support frame – here: 20 cm
