RID: 7th Session of the RID Committee of Experts' standing working group
(Prague, 22 to 24 November 2016)

Subject: Report on a rail accident at Tilburg on 6 March 2015

Transmitted by the Netherlands

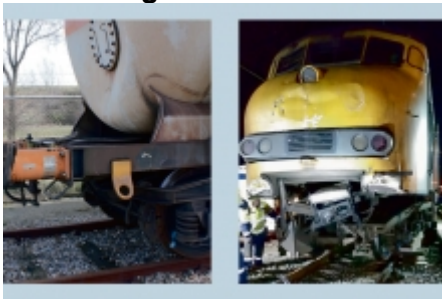
The damage

2. On 6 March 2015 a passenger train collided with a stationary freight train carrying dangerous substances at Tilburg in the Netherlands. Eight people on the passenger train were slightly injured. The last tank-wagon of the freight train was damaged and leaked butadiene (UN 1010). Some police officers became unwell after inhaling the escaped gases.
3. In response to the accident the [Dutch Safety Board](#) (Onderzoeksraad voor Veiligheid) carried out an investigation and published the report "Risicobeheersing bij spoorvervoer" (Risk management in railway transport) in which it has made several safety recommendations to the Ministry of Infrastructure and the Environment, the railway infrastructure manager, carriers and chemical companies.

7. The "climbing" of the passenger train was able to occur because the tank-wagon was not equipped with protection measures against overriding of buffers. Such protection is only mandatory for tank-wagons containing very toxic substances.

9. The Dutch Safety Board highlighted in its report the importance of supply chain responsibility. It recommends rail companies not to make operational decisions that lead to an increase in known and managed safety risks. In addition, the Board recommends that passenger train railway undertakings should not use train types with poor collision compatibility on routes designated for the transport of dangerous goods.
10. Furthermore, the Board is of the opinion that the Minister of Infrastructure and the Environment should require that all types of tank-wagons be protected against overriding of buffers, and that the rear wagon of a freight train may not contain any dangerous goods.
