**DIREZIONE GENERALE
PER LE INVESTIGAZIONI FERROVIARIE**
Italian Railway Investigation Body
Director General Marco Pittaluga

***Accident occurred
in Viareggio, June 29th 2009***

Presentation in Roma –11-13 April 2012

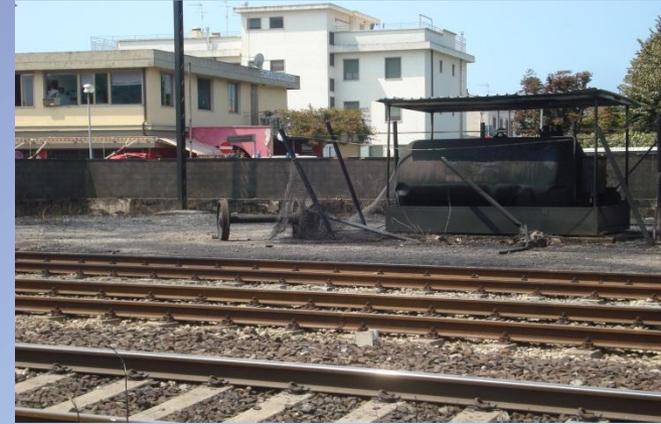
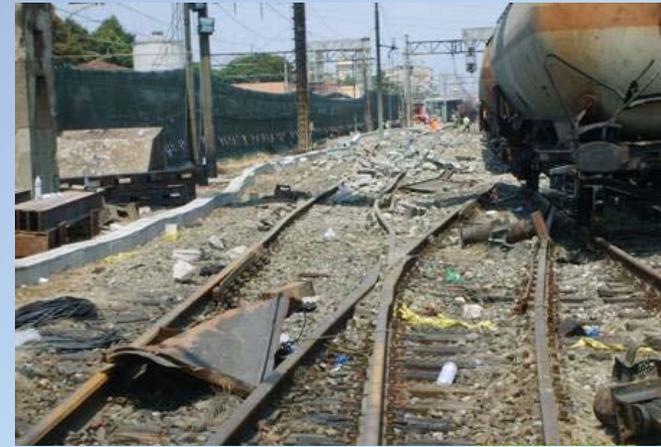
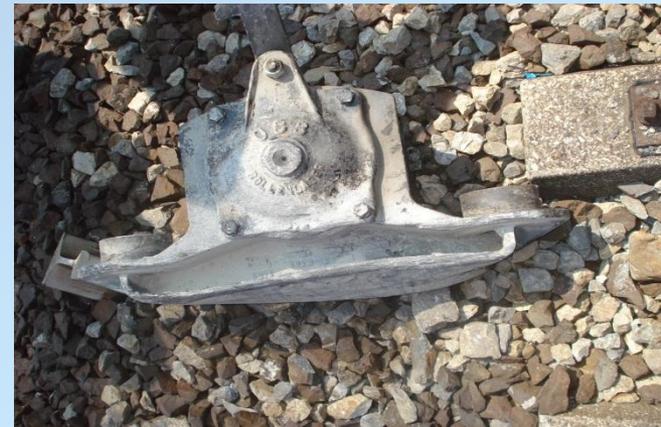
- June 29, 2009, hours 23.48: freight train 50325 derailment. Train from Trecate to Gricignano, composed of 14 tank wagons containing LPG
- cause: rupture of the journal of the second axle of the anterior bogie of the first tank car attached to the locomotive
- after 370 meters from the point of derailment, overturning of the first five rail tank
- broken axle hurled at a distance of 30 meters
- the other axle, bent, remains on the embankment about 15 meters from the stopping point of the wagon
- first tank car overturned, streaking along 100 meters, hits an element of infrastructure: rupture of the coat and leakage of LPG
- LPG fire and fire setted in the surrounding area: 32 dead and many injured
- along the path traversed by the first wagon overturned, several infrastructure elements deform:

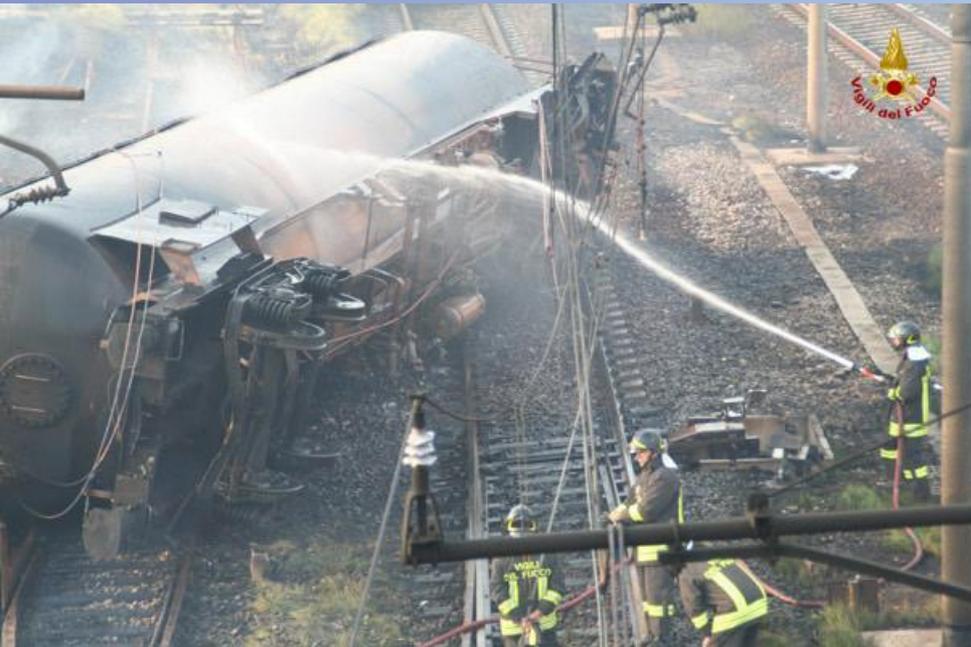
- Traveled a whole of 236.118 km, 228.768 km in Italy
- January 09, 2005, enters in Italy (Tarvisio) and never leaves the country area
- used for the relation Trecate - Gricignano (24 trips/year)
- tank sent in the CIMA Riparazioni of Bozzolo repairing garage on January 21, 2009:
 - checks and inspections
 - triennial tests provided by international regulations for tanks
 - replacement of two axles of the same bogie whose wheels were not geometrically suitable for running (the owner of the wagons proceeded to send the revised wheelset to CIMA that has been mounted them on the wagon. The revision of the wheelset and the subsequent tests, before of the sending to CIMA, were made in Germany by Jugenthal):

- LKM supplier's brand
- date of casting February 1974
- October 27, 1974 axle manufacturing
- UIC 811 technical specification reference
- March 02, 2009 the revised bogie is made available to FS Logistics that on March 04, 2009 provides to put it in circulation
- after revision ended on March 2, 2009 and to the date of the accident the wagon has traveled 22.525 km.

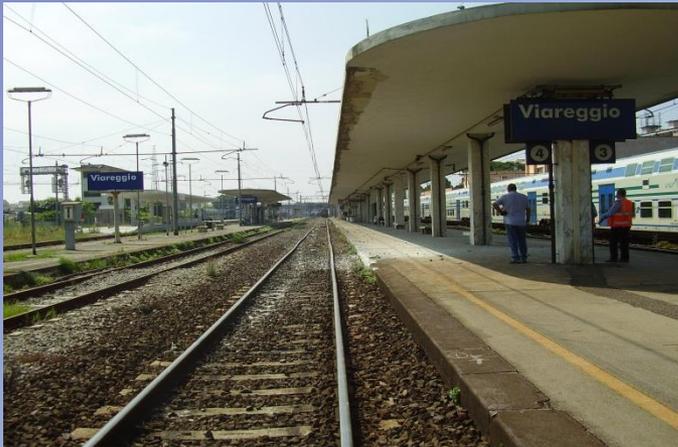
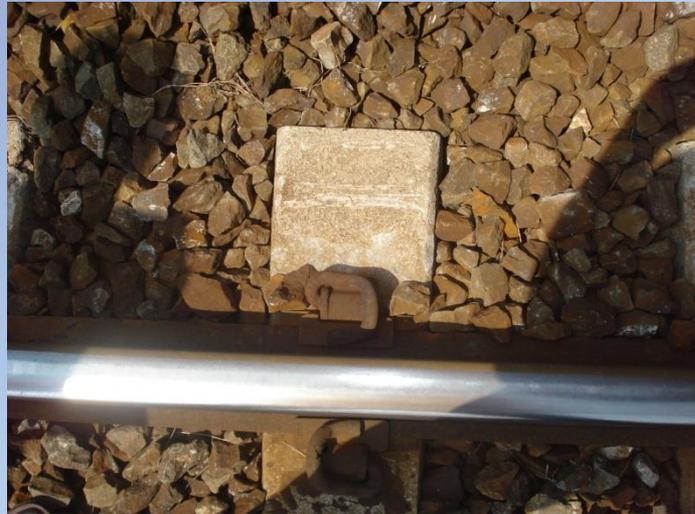
- with suitable equipment, check of the status of installation of the infrastructure, that was in perfect geometric conditions
- identification of the point of overlap
- defining of the cause of derailment: exclusively due to the broken axle
- On December 18, 2009 the investigators completed an initial report followed by an update in February 2011

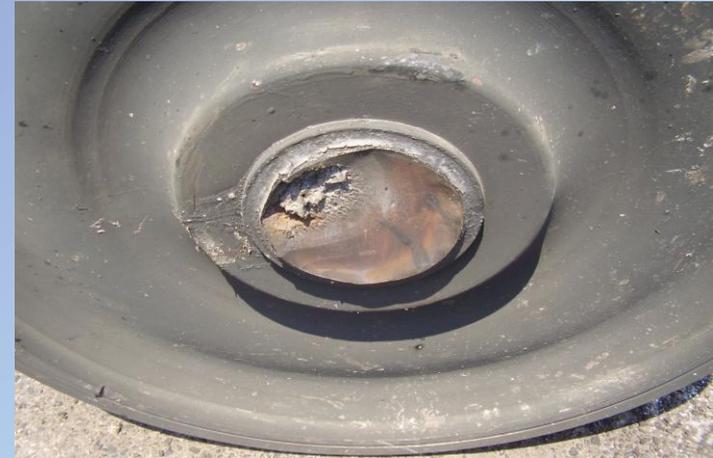
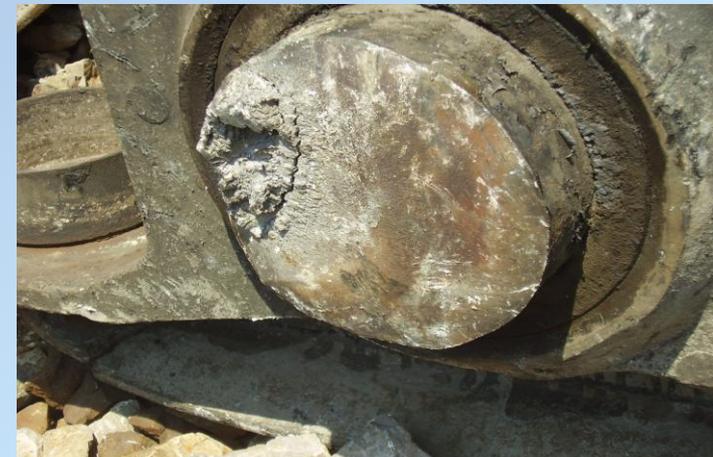
- Removing of the (fracture side) and extraction - from the bearing- of the part of the broke axle remained in the bush
- Removing hot of the three rings (bearing) and cleaning of the axle piece
- Stripping axle fractured
- Examination by ultrasound of the fractured axle to search for additional cracks
- Disassembly of the wheel placed in the opposite side of the fracture

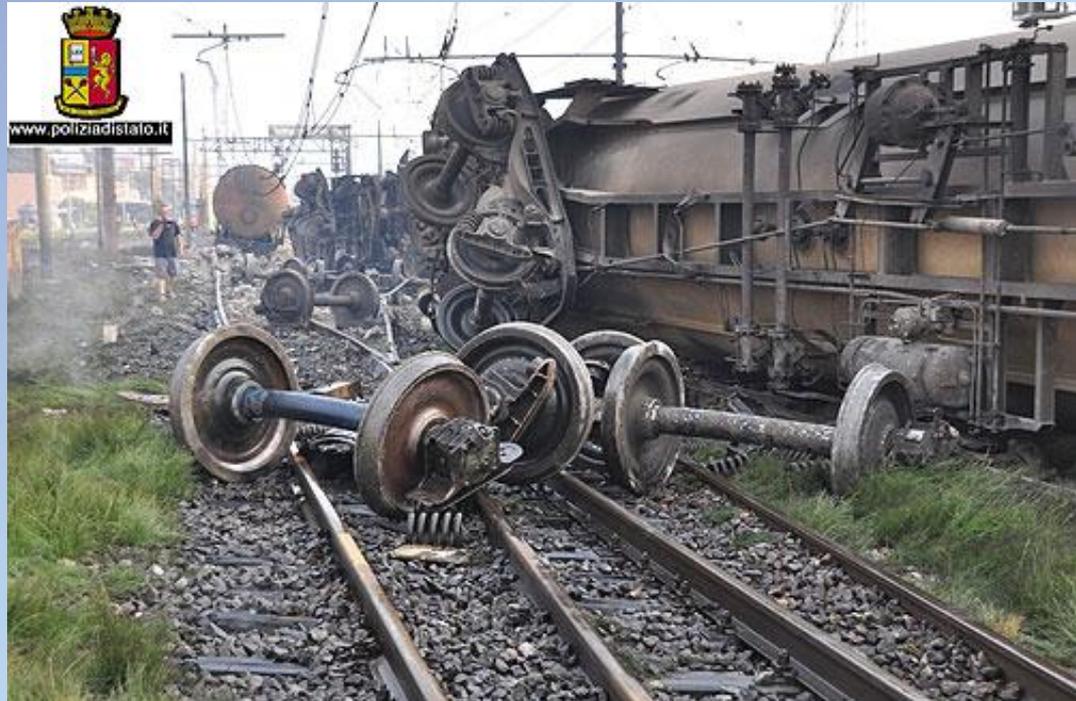
- The initiation of the fracture is originated from oxidation and thus are excluded other phenomena such as mechanical actions
- The propagation of the crack started from a single point with a diameter of 3/5 mm
