Inspectie Verkeer en Waterstaat
Ministerie van Verkeer en Waterstaat

Rail accident at Barendrecht

18 mei 2010

Description of the accident

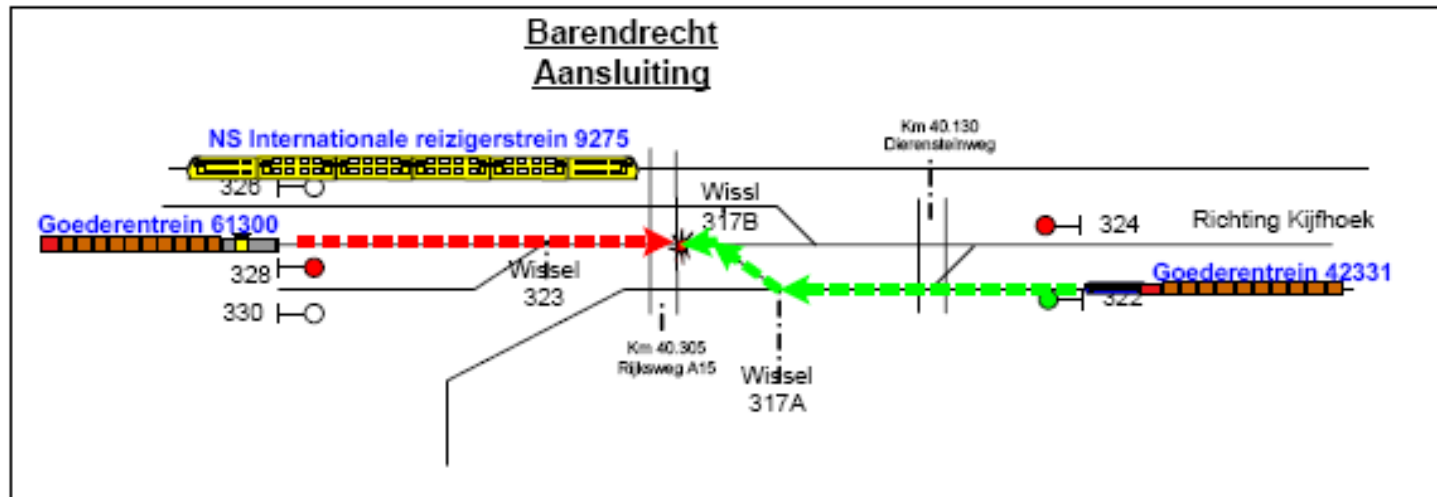
Afb.3: Situatieschets van de botsing

- Barendrecht aansluiting = Barendrecht junction
- Goederentrein = Freight train
- Wissel = (Switch) point
- Rijksweg A15 = A15 Motorway
- Internationale reizigerstrein = International passenger train
- Richting Kijfhoek = To Kijfhoek
- Dierensnelweg = Wildlife crossing

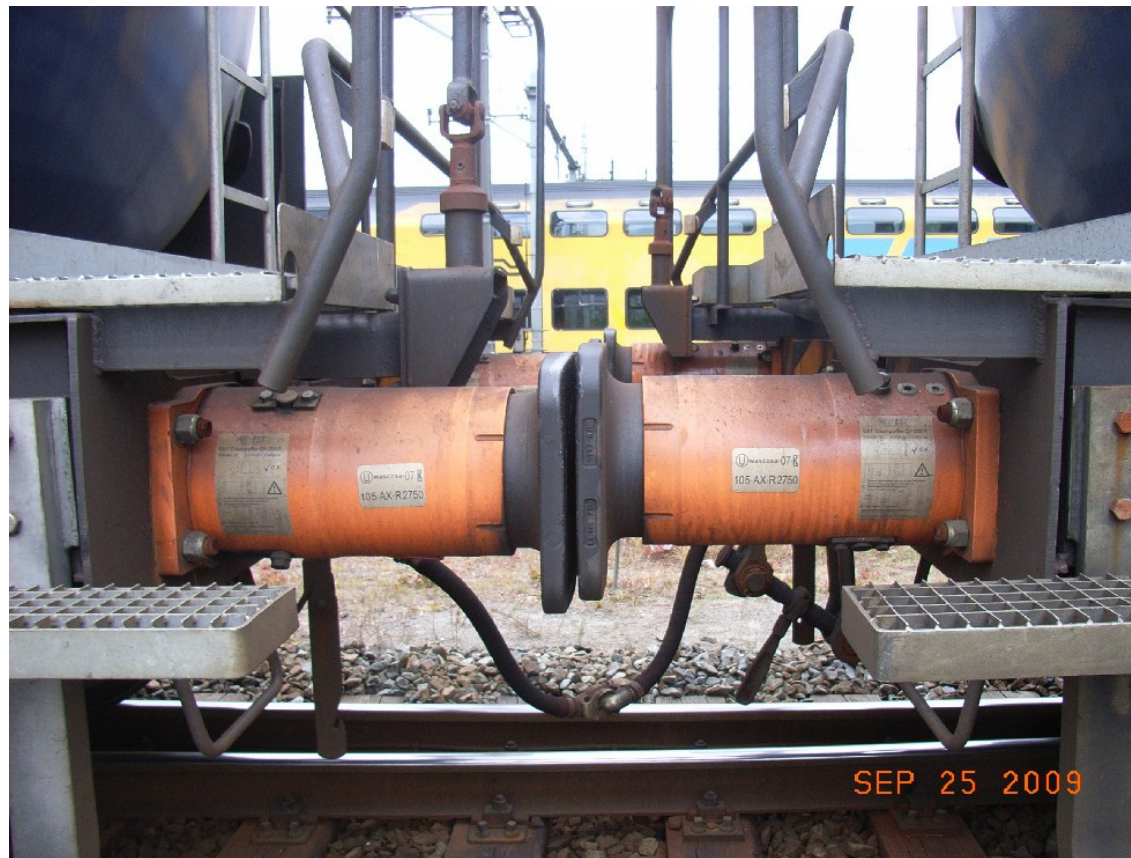
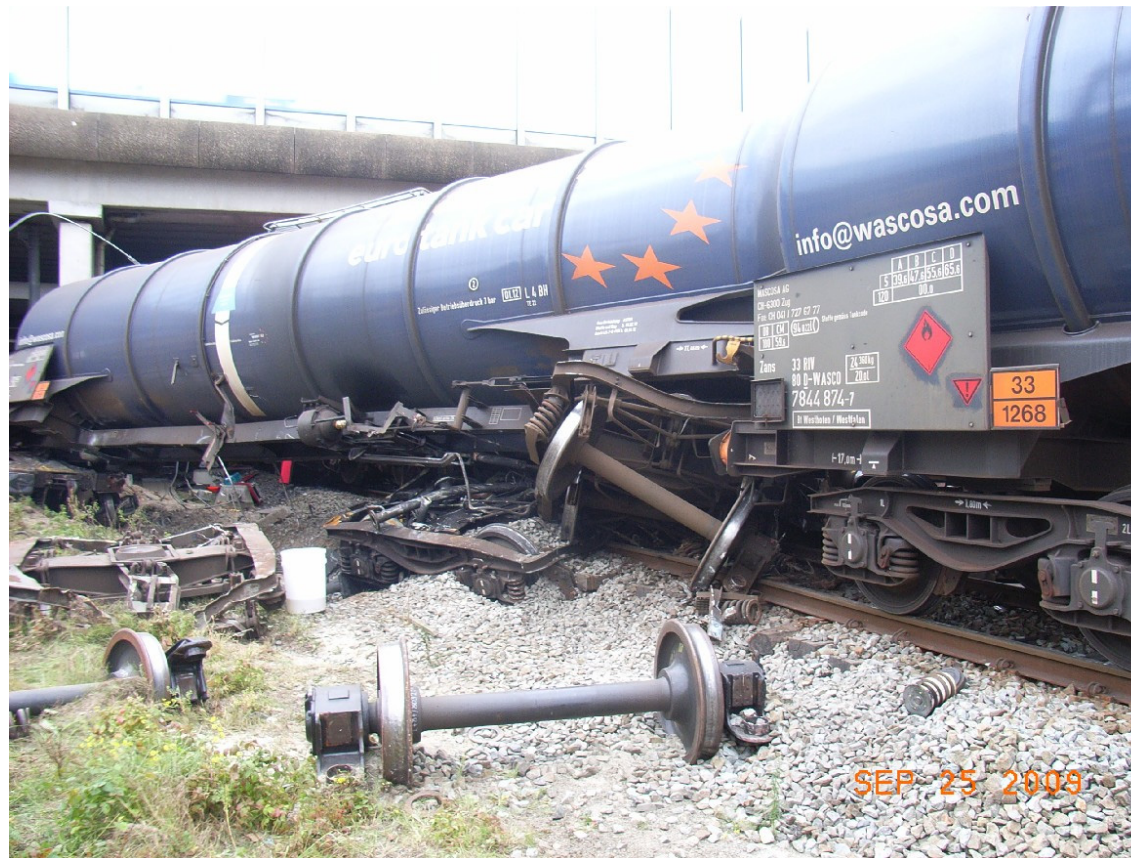
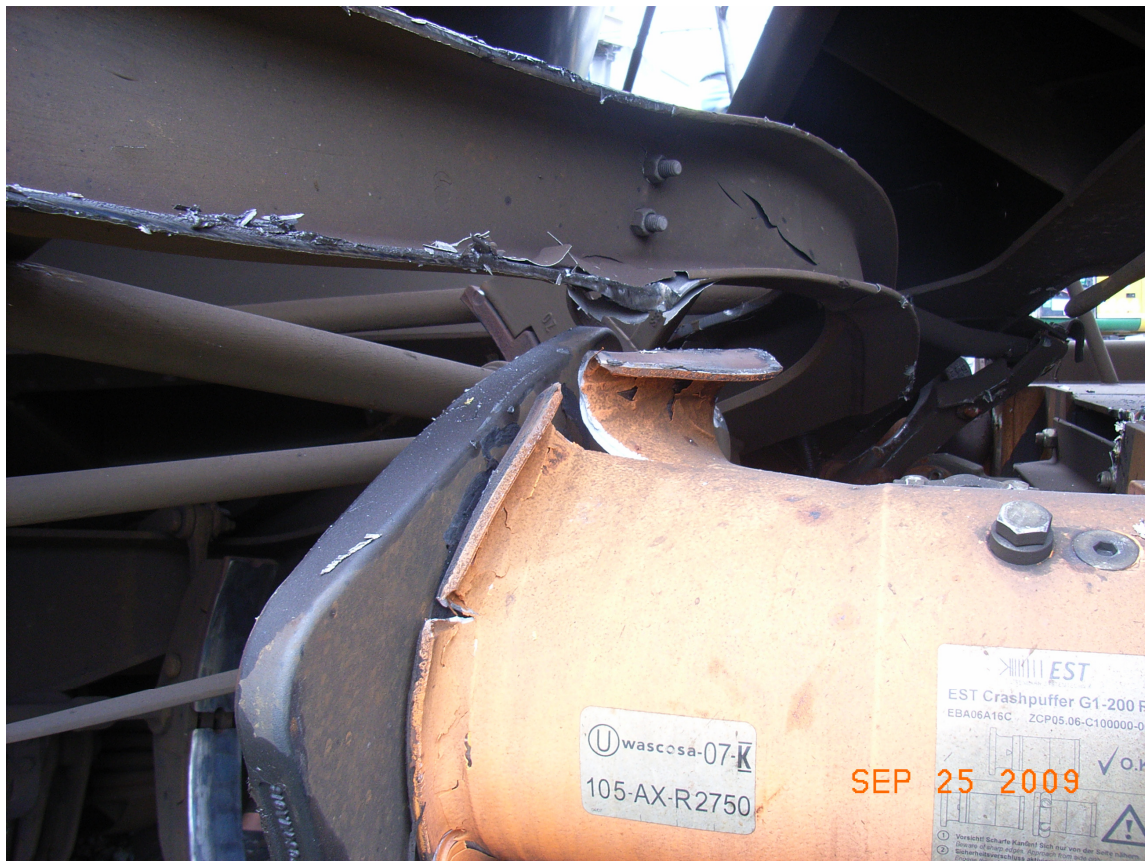
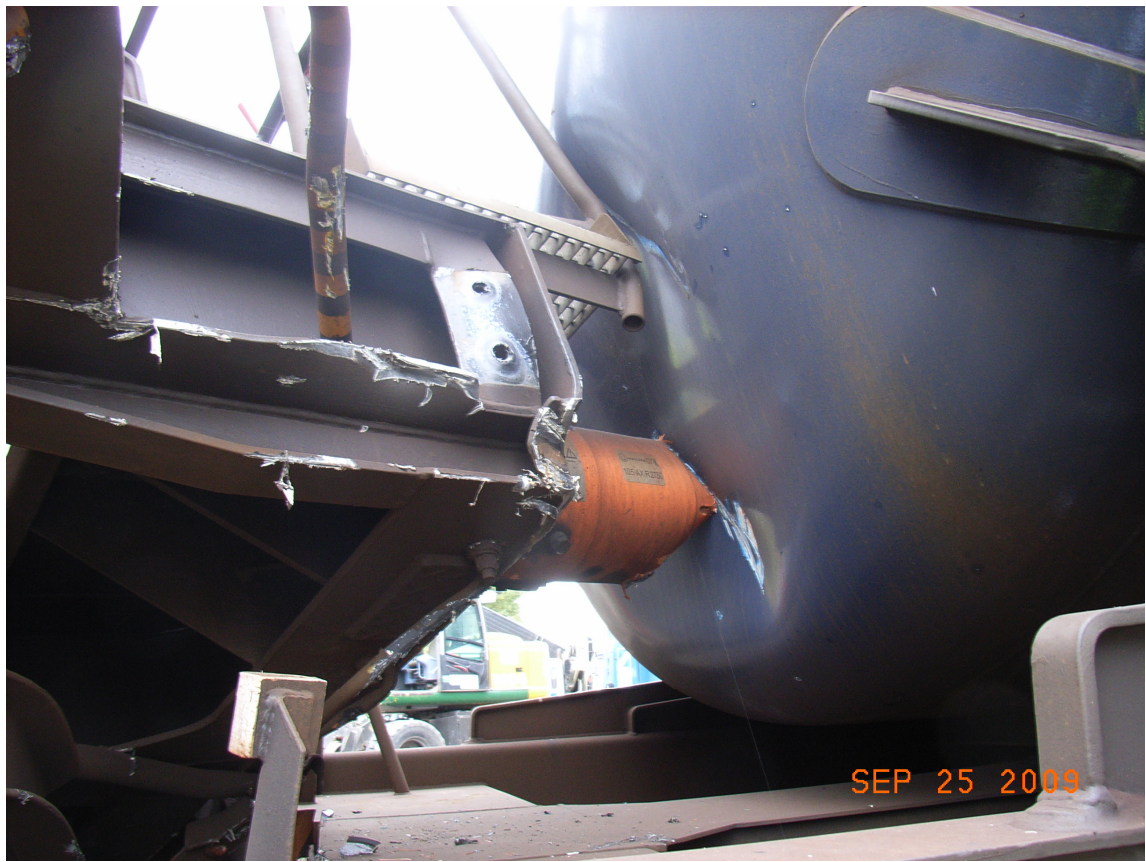
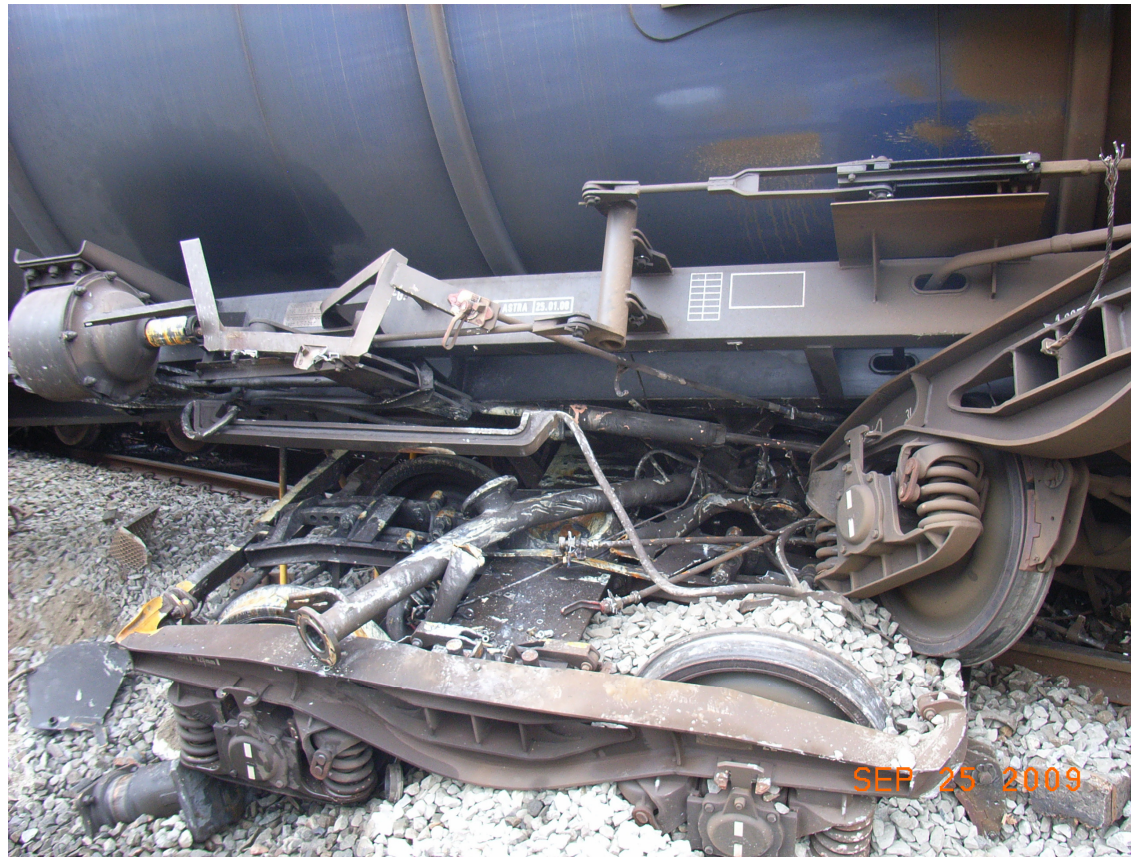
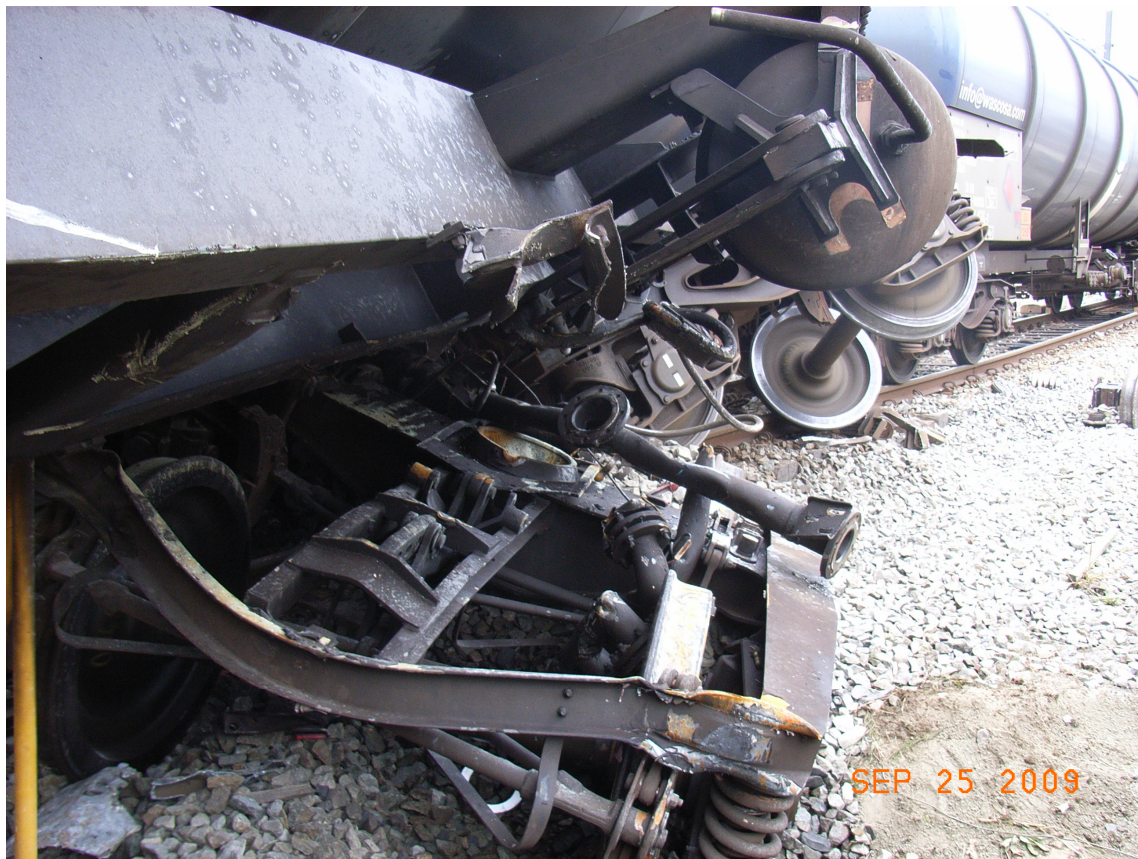
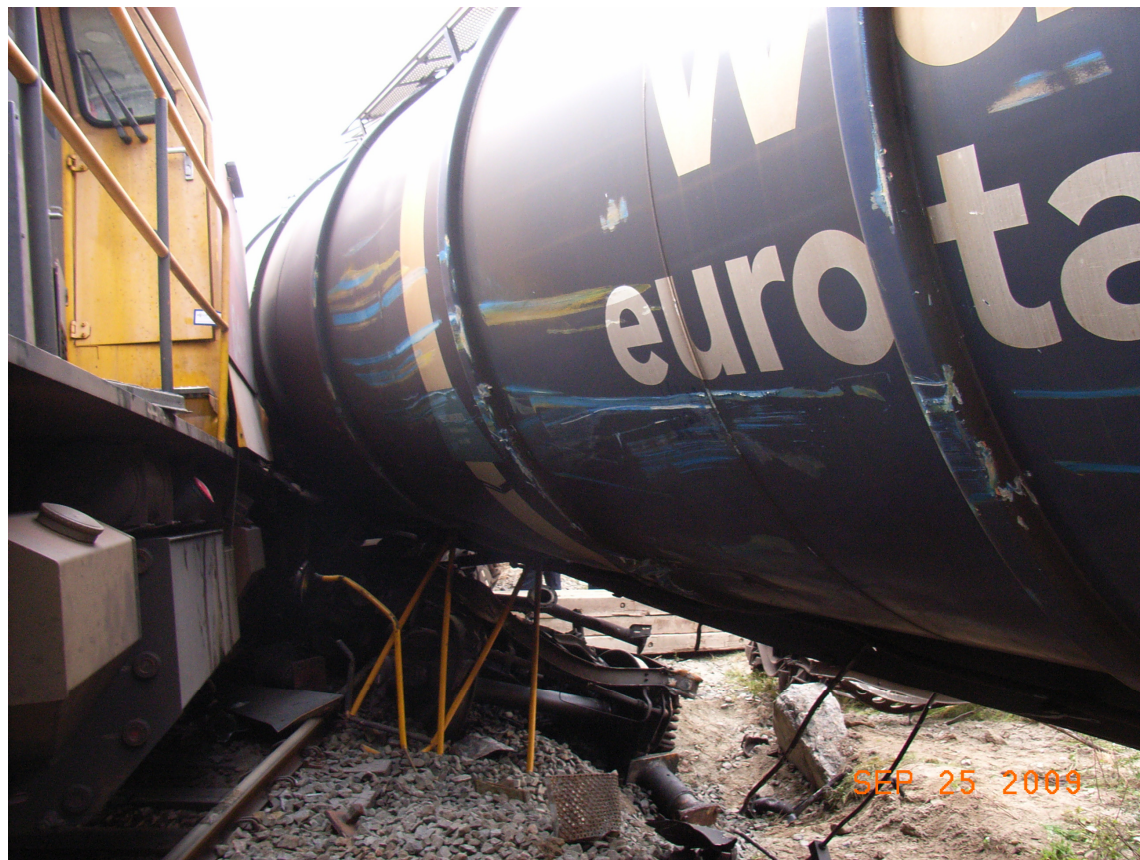
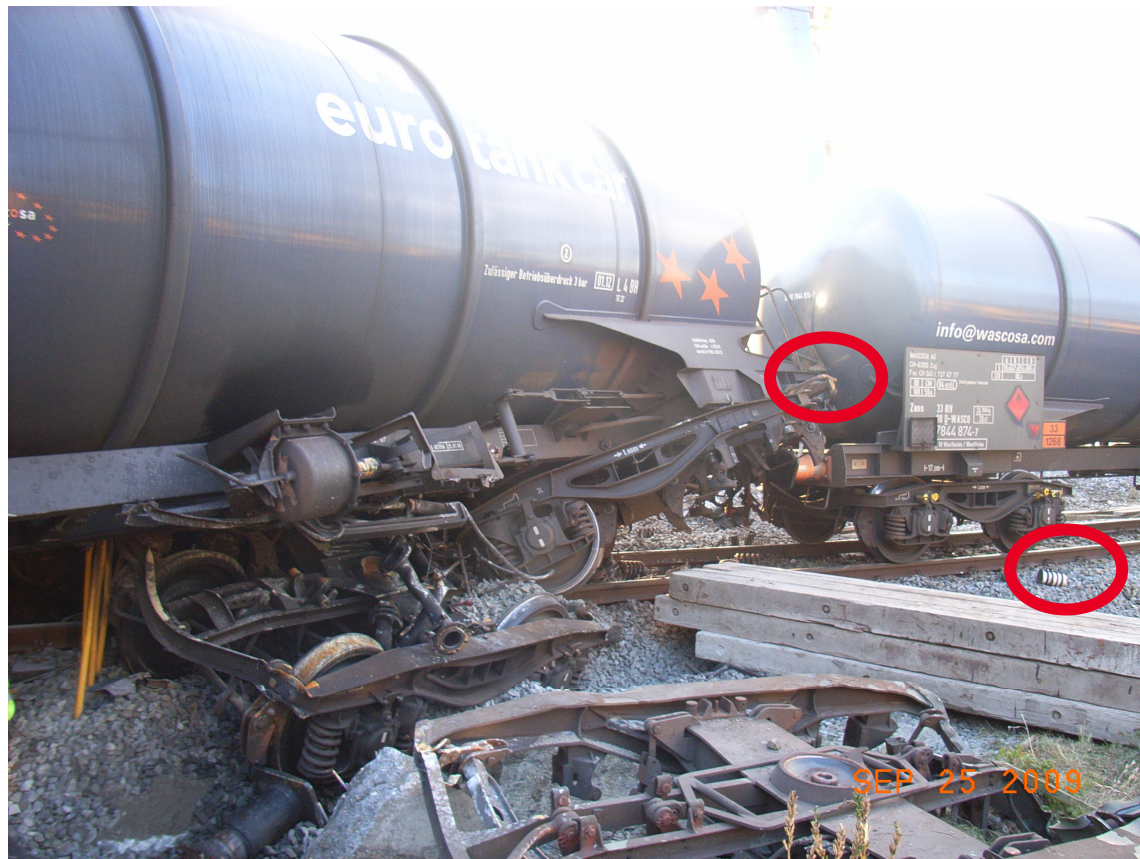
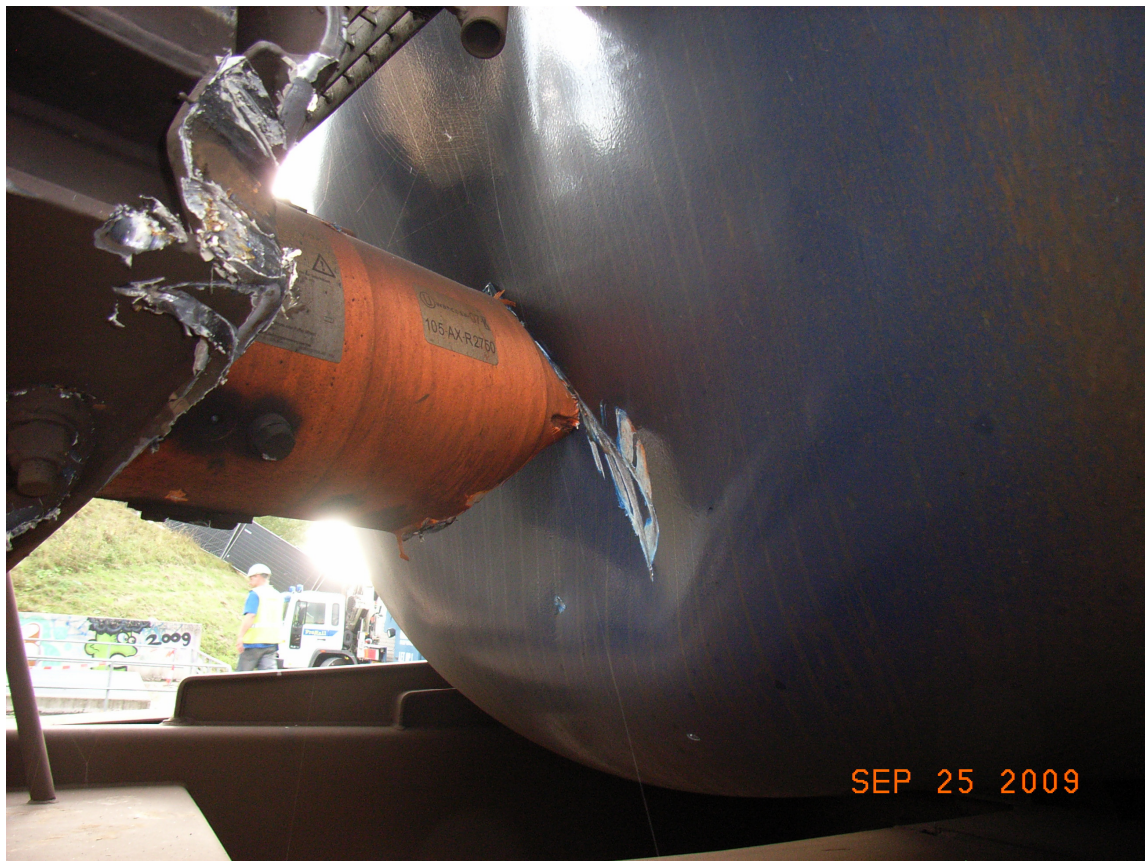
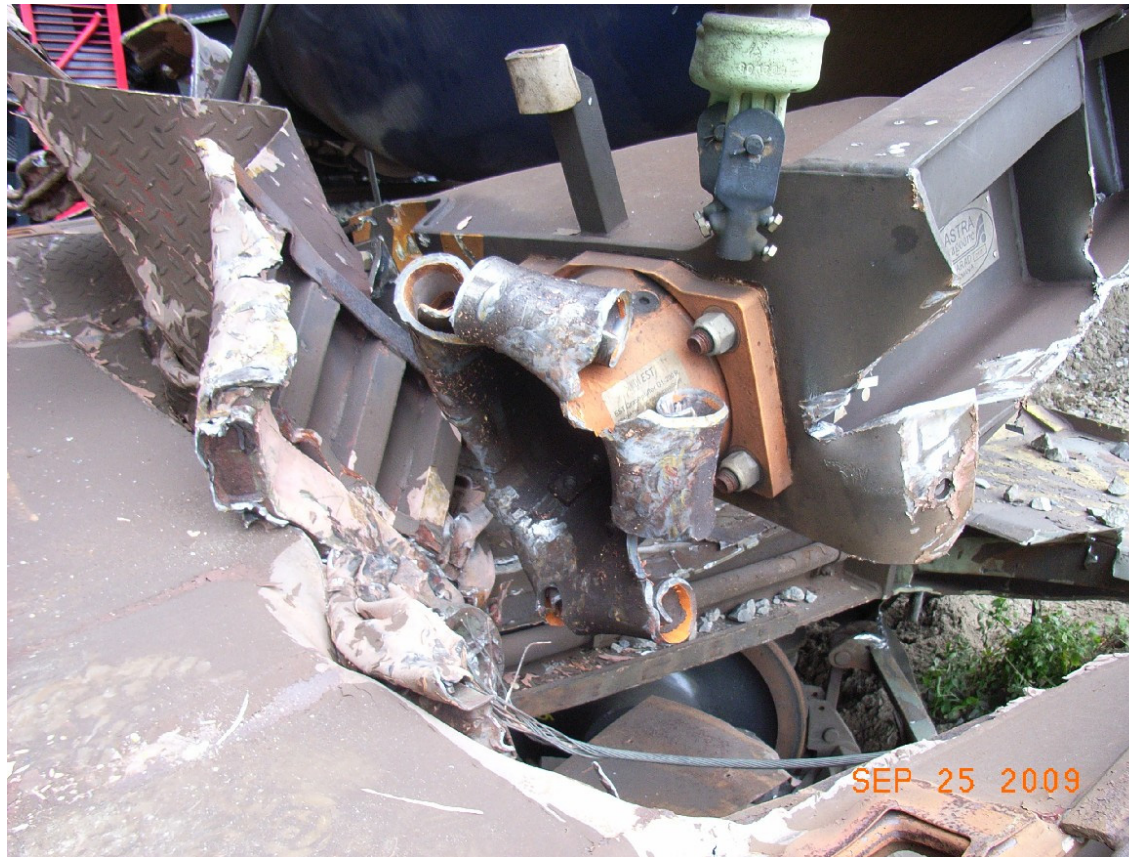
- Stop signal passages
- Trainspeed < 40 KPH
- No intervention by safety measures (on the track "ATB")
- The 7 tank wagons containing UN 1268 (HIN 33), natural gas condensate were all fitted with crash buffers, although these are not legally required (RID TE 22)
- Some of the crash buffers were activated
