OTIF/RID/CE/GTP/2012/1

Subject: Report according to RID 1.8.5 of events that occurred on 11 May 2012 in

Godinne (Belgium) during the transport of dangerous goods

Transmitted by Belgium

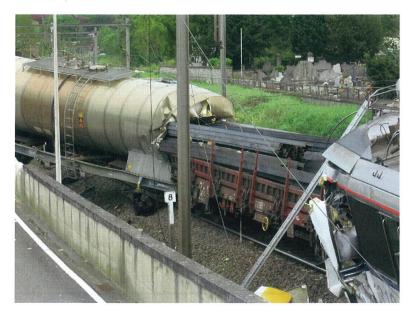
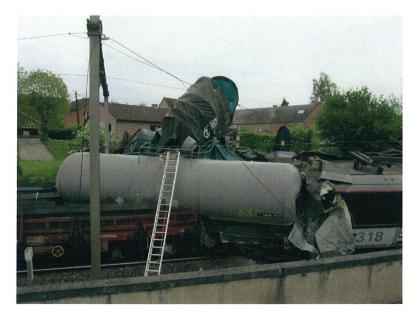
Annexe 3: photos de l'accident de Godinne

1. On 11 May 2011 in Godinne (Belgium), a freight train collided (at about 90 km/h) with another freight train, which was stationary. The train that was hit was composed of 28 wagons, 4 of which were carrying dangerous goods (22nd, 23rd, 24th and 28th wagons). The 27th wagon was a flat wagon loaded with metal girders. The 26th wagon was an empty, uncleaned L10BH tank which had contained a non RID product.

- the 28th wagon (last tank-wagon containing carbon disulphide 336/1131) was subject to a violent impact. It derailed, but did not leak. The tank was emptied before being righted;
- the 26th wagon (tank-wagon not containing dangerous goods) derailed and the L10BH tank was penetrated by the steel girders from the 27th wagon;
- the 24th wagon (tank-wagon containing butyl acrylates, stabilized 39/2348) was subject to a less violent impact. It derailed, but did not leak. The tank was emptied before the area was evacuated.
