INF. 5

**Subject:** Report according to RID 1.8.5 of events that occurred on 11 May 2012 in  
Godinne (Belgium) during the transport of dangerous goods – Follow-up

Transmitted by Belgium

**Subject:** Report according to RID 1.8.5 of events that occurred on 11 May 2012 in  
Godinne (Belgium) during the transport of dangerous goods

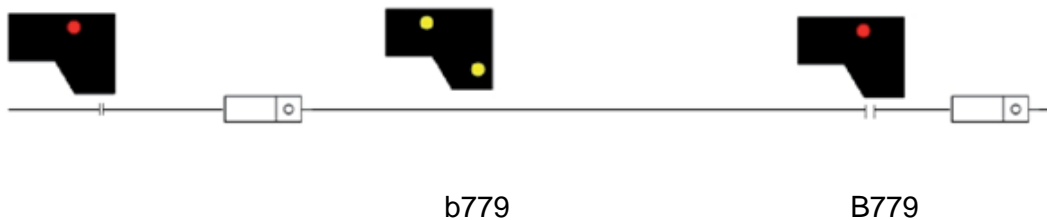
- The accident was caused by a signal failure. The warning signal b779 was green (instead of 2-yellow) followed by the red signal B779.

This is the normal situation:

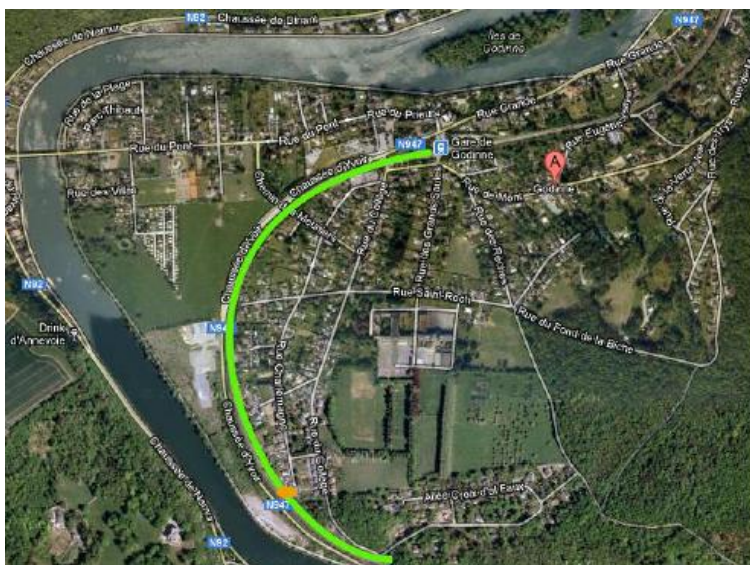
The day of the accident, signal b779 was green:

- Because of the topology of the track, the driver was unable to see the red signal B779 or the rear of the preceding train. When the driver realized that a collision was going to occur, it was too late to stop. The speed of the train was about 85 km/h.

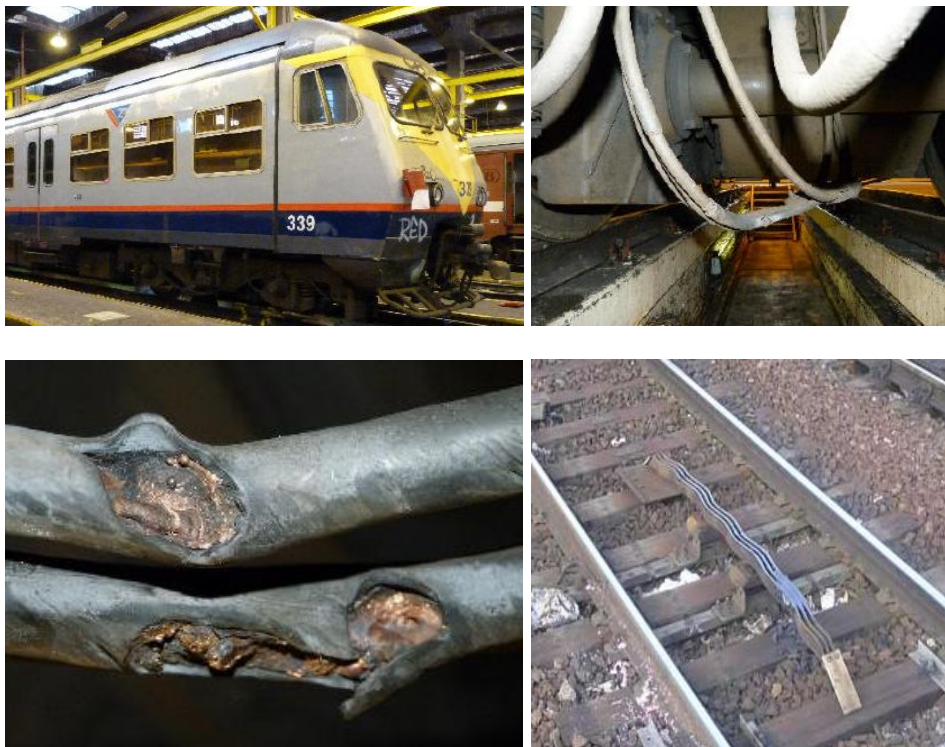
Primary cause:

7. The signal failure was caused by excess voltage being applied to the signal command circuit by damaged power cable on a traction unit.

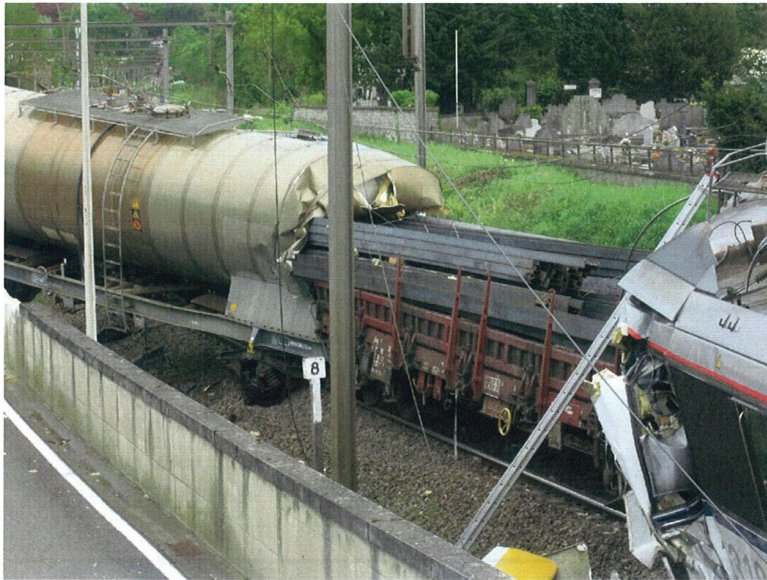
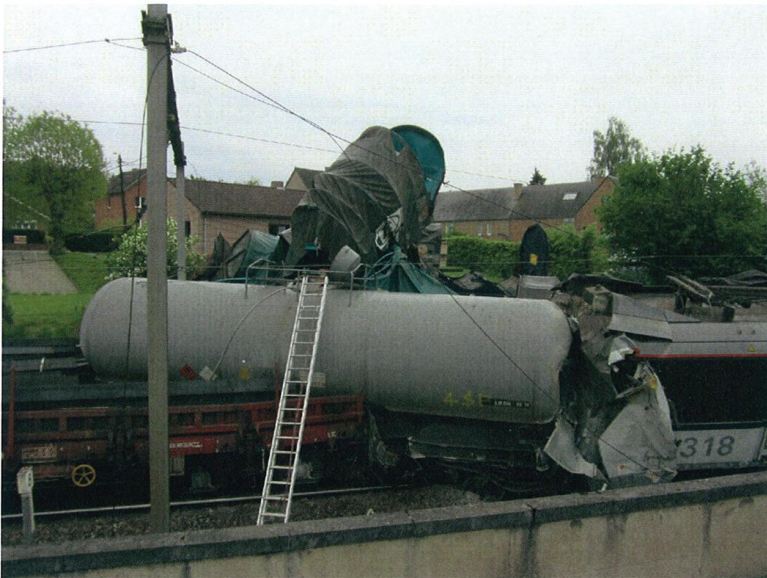
Annexe 3: photos de l'accident de Godinne

2. Following the impact:
  - the 28<sup>th</sup> wagon (last tank-wagon containing carbon disulphide 336/1131) was subject to a violent impact. It derailed, but did not leak. The tank was emptied before being righted;

- the 26<sup>th</sup> wagon (tank-wagon not containing dangerous goods) derailed and the L10BH tank was penetrated by the steel girders from the 27<sup>th</sup> wagon;

- the 24<sup>th</sup> wagon (tank-wagon containing butyl acrylates, stabilized 39/2348) was subject to a less violent impact. It derailed, but did not leak. The tank was emptied before the area was evacuated.
