OTIF/RID/CE/GTP/2014/18

Subject: Report on incidents in the carriage of dangerous goods in accordance with RID
1.8.5 (Hamburg-Billwerder, 3 July 2013)

Information from Germany

**Extract from the Eisenbahn-Bundesamt (EBA) report
(Hamburg/Schwerin branch) dated 4 July 2013**

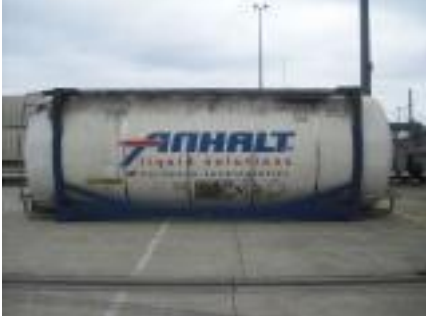
Photograph 6: Tank-container of same construction

In order to clarify the question of whether it was simply human error or problems with the loading method that caused the incident, on 4 September 2013, EBA staff had a meeting at Billwerder with the people involved. An operator provided a tank-container of the same construction, on which the tank itself protruded over the container frame **on both sides** (so-called swap tank-container).

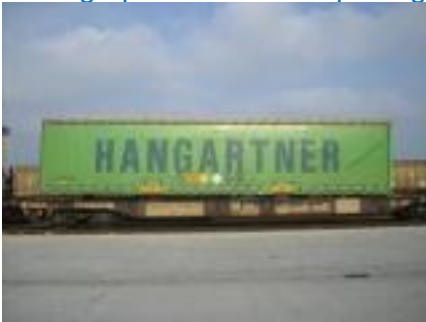
Photograph 7: Illustrative photograph – Loading a trailer onto a pocket wagon

The tank-container was loaded onto a container carrying wagon, which was also the same construction as the one involved in the incident. This wagon design type is also used for loading trailers (so-called pocket wagon).

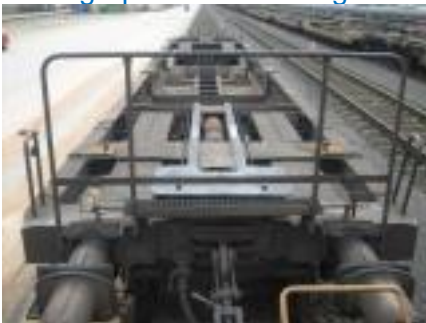
Photograph 8: Pocket wagon of same construction

2. The container carrying wagon was a so-called "pocket wagon" (design type 743). This wagon design type is also used especially for loading trailers. It has a supporting frame for the trailer's kingpin.

3. However, this construction seems to cause problems when loading tank-containers. In this case, once the tank-container had been placed on the carrying wagon, there was only 20 cm gap between the tank and the support frame.
