**DIREZIONE GENERALE
PER LE INVESTIGAZIONI FERROVIARIE**
Italian Railway Investigation Body
Director General Marco Pittaluga

***Accident occurred
in Viareggio, June 29th 2009***

Presentation in Roma –11-13 April 2012

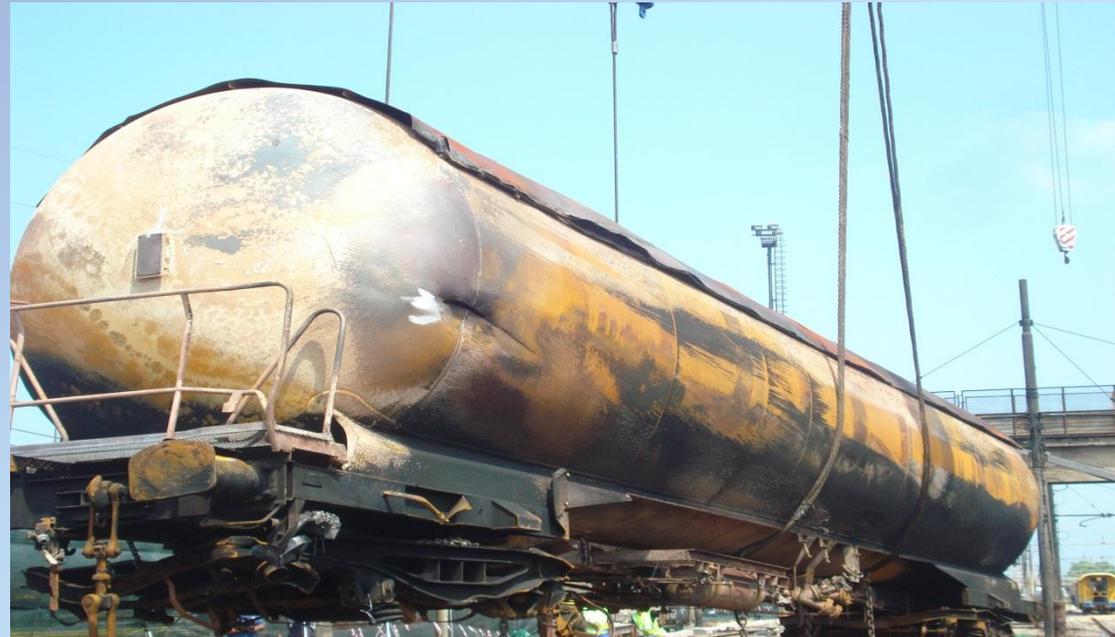
- tank for liquid gas under pressure, sealed, with sunscreen, designed for a pressure of 25 bar and filling from the bottom
- year of construction: 2004
- Producer: Chemet SA
- approval: EBA - Eisenbahn - Bundesamt (Federal Office for Railways - Germany)
- test (and design) pressure: 2.5 MPa (25 bar)
- plating thickness 12 mm, funds thickness 13.5 mm
- capacity 109,800 liters
- initial control: December 2004 (with a hydraulic control test, pressure 25 bar)
- interim control: February 19, 2009 (tightness test)
- tests and inspections performed on the tank: February 19, 2009 type of verification: external inspection, leak test at 6.5 bar, loading/unloading test
- next revision date: December 15, 2012
- tank containing "Hydrocarbon gas mixture, liquefied, UN number 1965 - Hazard Identification Number 23"

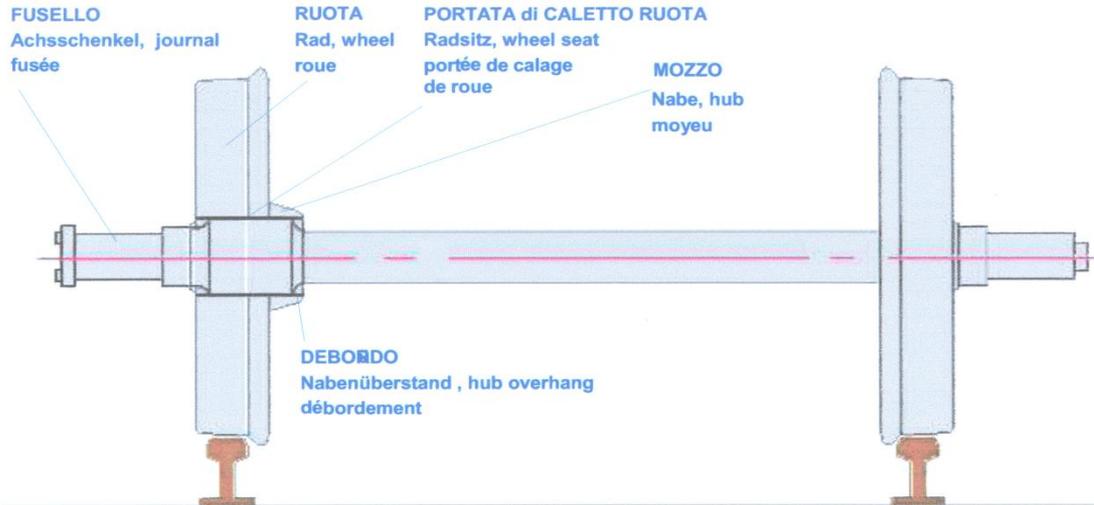
Sala Montata

Radsatz
Wheelset
Essieu monté
